SBCA TREE CONSULTING

Subject: Tree Removal Recommendation

Location: 1001 Pearl St.

Species: *Myoporum (Myoporum laetum)*

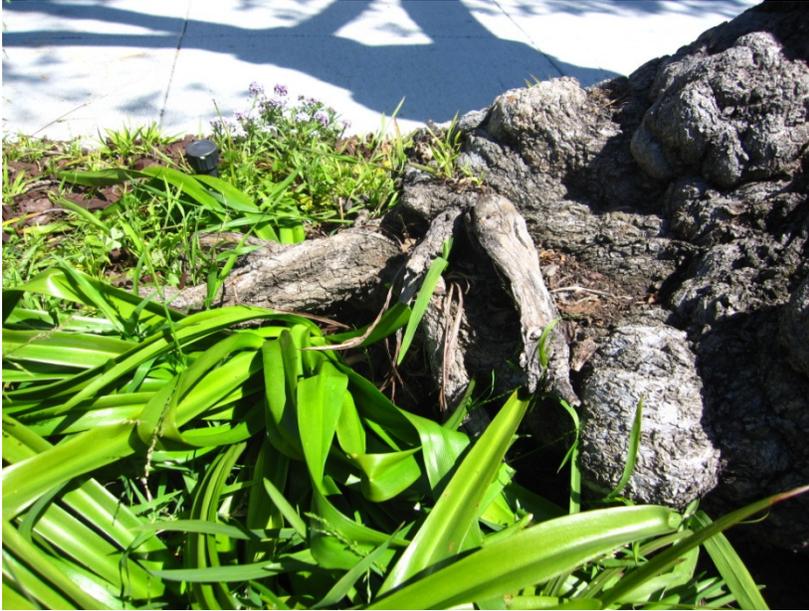
Hazard Evaluation – Tree failure potential is severe. Uplifted roots indicate the tree is in the process of falling over slowly. However, the tree is not very large and target rating is low, with the potential for damage to a car if parked underneath during the time of failure.

Photo 1. Photo to the right show the uplifting roots on the east side of the tree, opposite the lean. It appears the tree has been in the process of failing for some time and will continue to do so as the root system deteriorates.

It is recommended that the tree be removed and replaced at a time when it can be efficiently undertaken. It may be best if no cars park under the tree in the meantime.

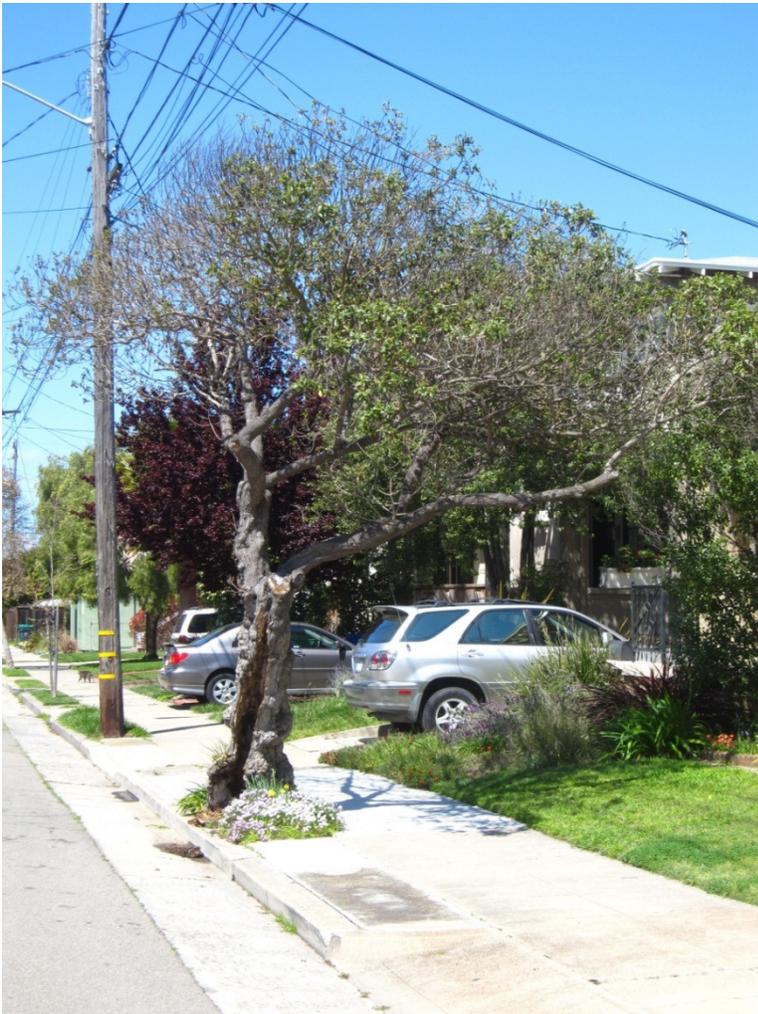
The tree has a DBH of 16 inches and is approximately 20 feet in height. The tree displays a 40 degree lean to the east. A large decay area emanating from an old pruning wound begins 5.5 feet up the trunk and continues down to the ground. Over 70% of the tree is decayed or hollow. Roots on the west side appear to be uplifting. The tree displays distorted and sparse foliage, a sign of *Myoporum* Thrips (*Klambothrips myopori*) infestation. Live crown ratio is 5-10%.

Myoporum Thrips – Infestation of thrips is the event contributing to this trees transition from declining to dead on the mortality spiral¹.

Photo 2. Photo to the left shows the tree with sparse foliage and a large cavity 5.5 feet up the trunk. The tree is at the end of its life and should be removed and replaced.
