SBCA TREE CONSULTING

Date: August 25, 2014

Subject: Tree Safety

Location: 1700 Block of Chapin

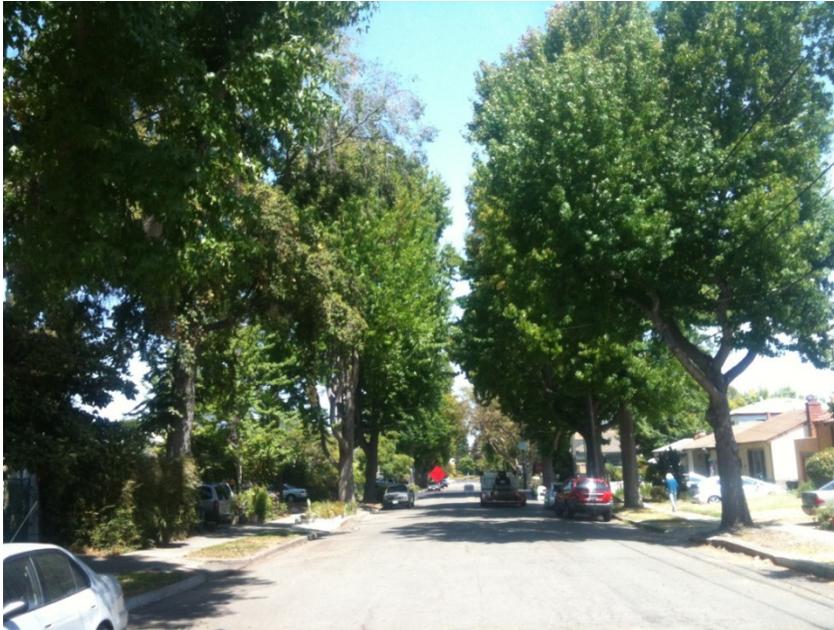
Photo 1. Photo to the left shows the street scape with mature Liquidambar trees. They provide valuable amenities to the block, including shade, beauty, and habitat.

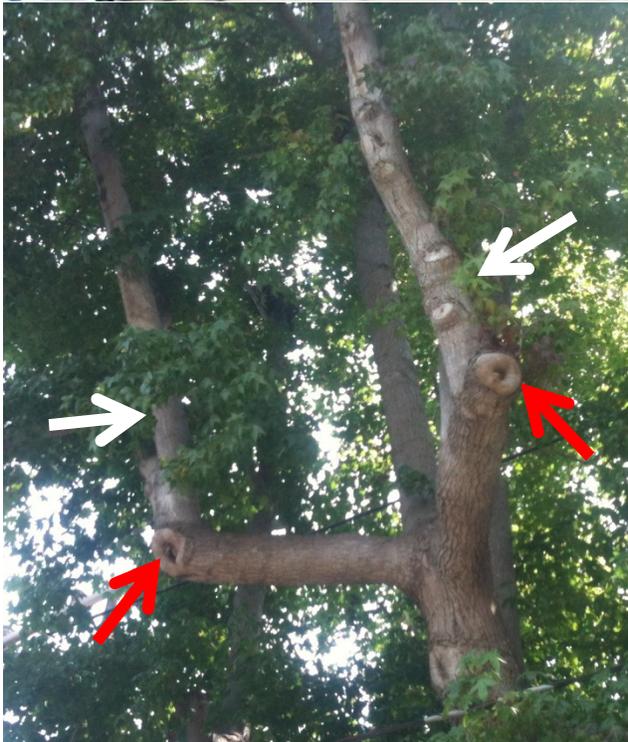
Photo 2. Photo to the left shows Tree #5 at 1728 Chapin. This tree, like all the Liquidambar on the block, were headed the past. Large branches were removed the trees were not able to close the wounds before decay set in (red arrows). Weakly attached new branches developed from epicormic sprouts, which are now very large (white arrows). Investigation to determine the extent of the decay in these areas is necessary to evaluate associated tree risk.

Aerial Decay Assessment – It is recommended that any of the *Liquidambar* trees designated for pruning receive an aerial inspection of the scaffold and upper crown. This is conducted prior to pruning. The investigation involves visual inspection, sounding with a mallet, and use of a Resistograph or other tool to accurately assess the level of decay if deemed necessary. Trees of special note for earlier decay assessment are Trees #4 (1720) and #5 (1728). It is recommended that these trees be assessed as soon as it is feasible.

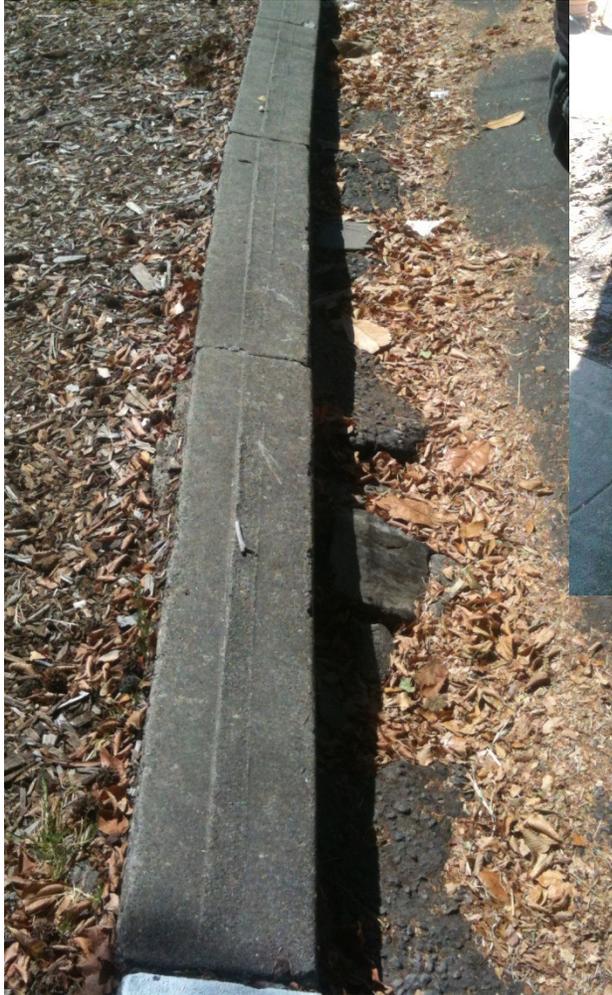
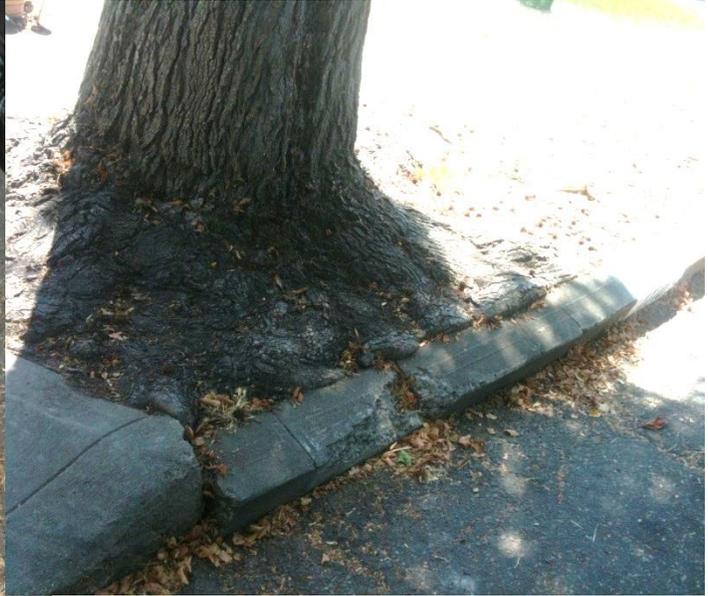
Photo 2 and 3. Photos to the left and above shows the extensive curb and gutter displacement adjacent to Tree #2 in front of 1710 Chapin. All trees on the block have caused hardscape displacement.

Prune or Remove Tree #2 – The large limb over the drive was noted as having extensive decay. This limb will require removal. This tree suffers from the removal of large limbs in the past as evidenced by the large wounds. With the fair health, poor structure, major root-hardscape conflicts and minimal aesthetic contribution, this tree would top the list of removal candidates.

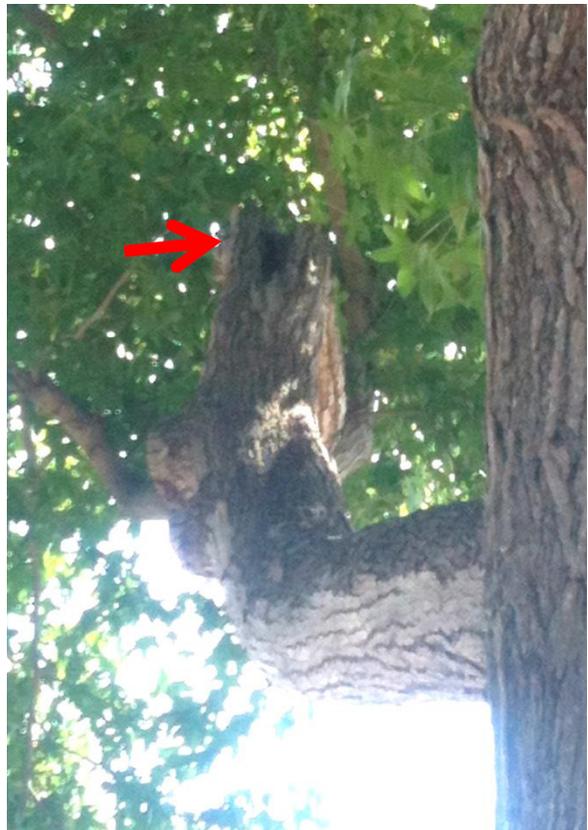
Photo 4. Photo to the right shows the decay observed on the large branch over the drive at 1710 Chapin (red arrow). Aerial inspections are required for all trees to understand if other branches are significantly decayed.

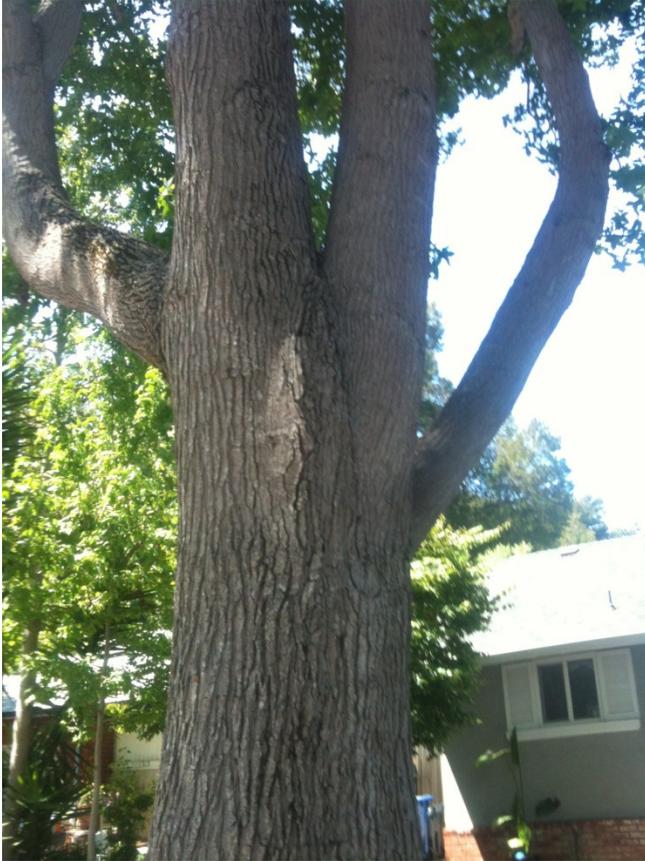
Photo 5. Photo to the left shows Tree #6, 1723 Chapin and codominant limbs with included bark between their attachment. These attachments are inherently weak because bark precludes the joining of wood. To mitigate, future pruning should concentrate on one stem to create a disproportionate size between the two stems. Other included bark attachments within the tree canopy should be pruned in a similar manner.
