Date: June 1, 2007

Location: 1704 Chapin

Species: Liquidambar Tree

Subject: Root-Sidewalk Conflict

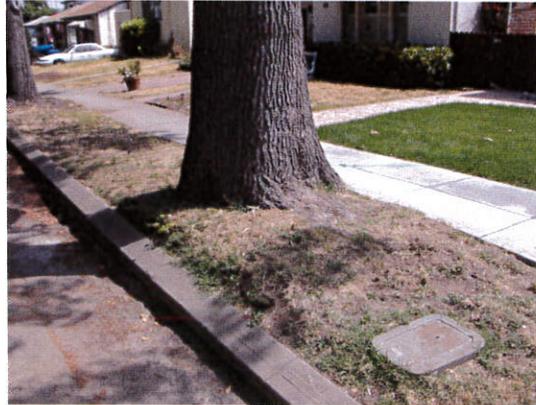
This tree has been pruned excessively and is very one sided. Because of the pruning the tree is sure to become a liability. In addition roots were earlier severed at the edge of the sidewalk, likely done when the sidewalk repairs were last made. The roots are causing minor curb displacement and appear to be under the street.

Photo 1. Photo shows the base of the liquidambar tree is the parkway. The curb is being displaced and the street has indications that roots are under and lifting the pavement.

Apparently, large roots were cut when the sidewalk was last repaired.

If a phased tree replacement program is to be implemented, this tree would be a candidate for earlier replacement due to its condition. A smaller stature replacement tree could be planted slightly farther from the water meter.

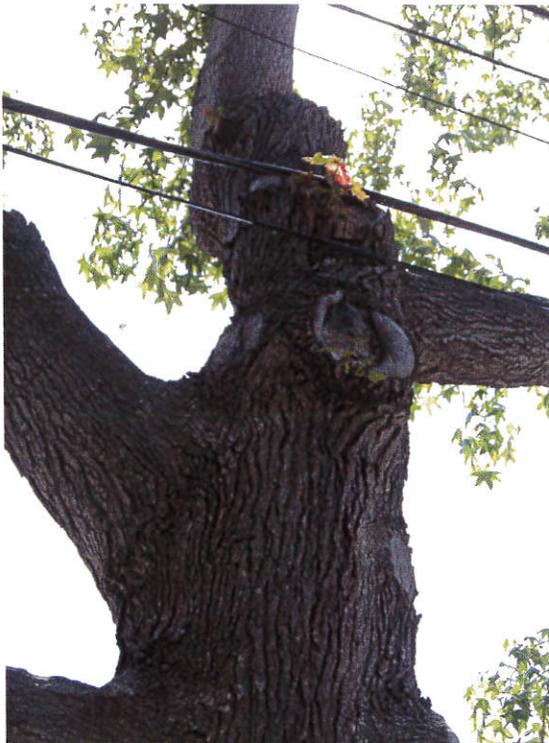
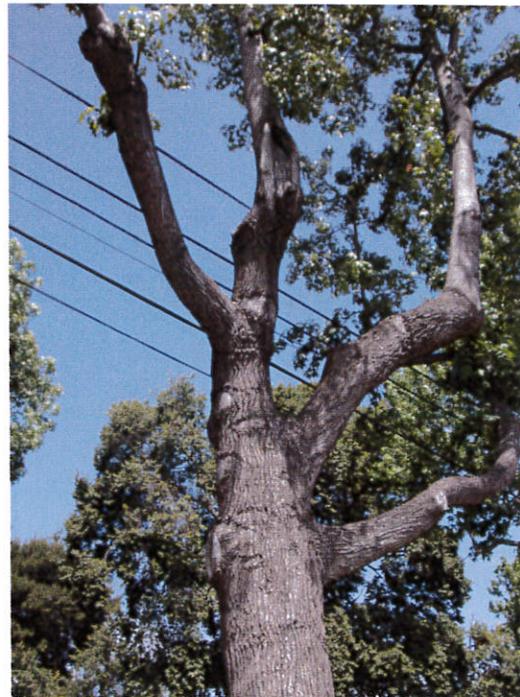
The liquidambar tree has a DBH of 34". Health and structure are both poor due to the recent pruning that appears to have removed 70% to 80% of the tree. Large pruning wounds were created. If the tree remains, decay is expected to compromise the safety of the tree in time. Repair is not possible and corrective pruning will only help slightly and be quite costly.

Photos 2 & 3 below show the crown of the tree that has been pruned heavily on one side.
