Steve Batchelder, Consulting Arborist
1534 Rose Street, Crockett, CA 94525
WC ISA Certified Arborist #228
Calif. Contractor Lic. (C-27) 533675
Phone (510) 787-3075, Fax (510) 787-3065
E-mail sbcatree@comcast.net

Date: 2/2/2008

Locations: 1720 Chapin

Subject: Root-Sidewalk Conflict

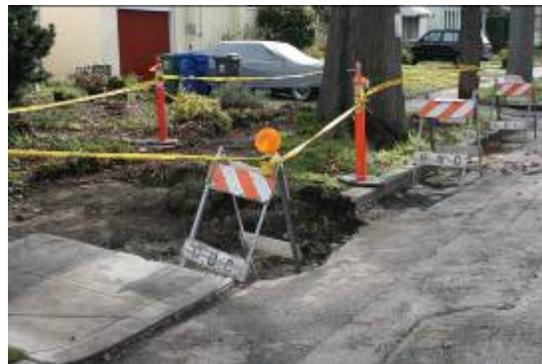
This tree is becoming more problematic due to the large size and the expanding decay cavity. It does appear that the necessary repairs can be made without compromising the health and stability of the tree. This tree is wider than the parkway width and will continue to expand.

The liquidambar tree has a DBH of 40". The health cannot be accurately assessed when leaves are not present. The leaking water from the cavity indicates that the decay extends up to prior heading cut wounds. It does not appear to be a safety concern at this time.

The roots were observed below the gutter area.

Photo 1. Photo to the right shows the liquidambar tree at 1720 Chapin. It does appear that the repairs can be accomplished without compromising the health and safety of the tree.

It does appear that the tree can be retained at least until the next repair cycle.

The root below the gutter will require some shaving to increase the amount of time until repairs are again required.
