*Steve Batchelder, Consulting Arborist*  
1534 Rose Street, Crockett, CA 94525  
WC ISA Certified Arborist #228  
Calif. Contractor Lic. (C-27) 533675  
Phone (510) 787-3075, Fax (510) 787-3065  
E-mail sbcatree@comcast.net

**Location:** 1720 Chaplin

**Species:** Liquidambar Tree

**Subject:** Root-Sidewalk Conflict

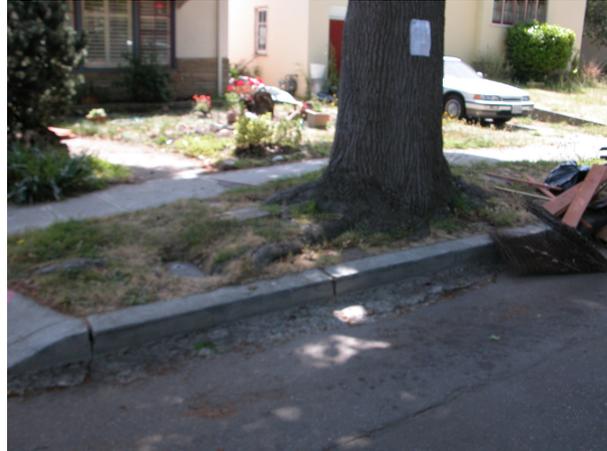
The parkway planting strip is 6' wide. The curb, street and sidewalk adjacent to the tree have all been displaced. The street pavement uplift appears to be impeding the flow of water in the gutter.

**Photo 1.** Photo shows the subject tree in the 6' wide parkway. The street is elevated, likely by tree roots.

It is recommended that consideration be given to removing and replacing this tree primarily due to the costs associated with maintaining this tree.

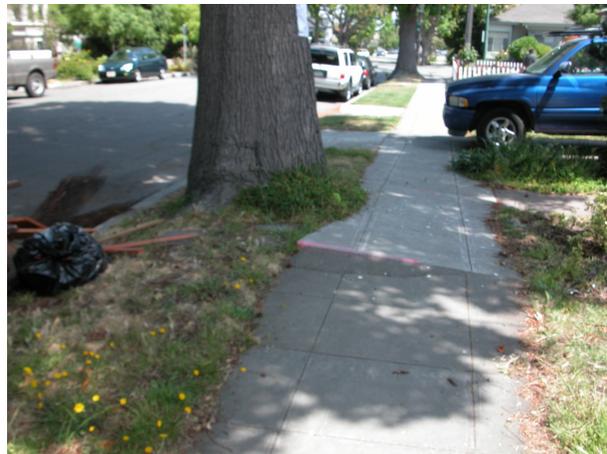
**Photo 2.** Photo shows the parkway planting area and the adjacent sidewalk that has been previously repaired. Even with an expanded area around the tree the damage is expected to continue to occur at more frequent intervals.
