Steve Batchelder, Consulting Arborist
1534 Rose Street, Crockett, CA 94525
WC ISA Certified Arborist #228
Calif. Contractor Lic. (C-27) 533675
Phone (510) 787-3075, Fax (510) 787-3065
E-mail sbcatree@comcast.net

Locations: 1728 Chapin

Species: Liquidambar Tree

Subject: Root Street Conflict

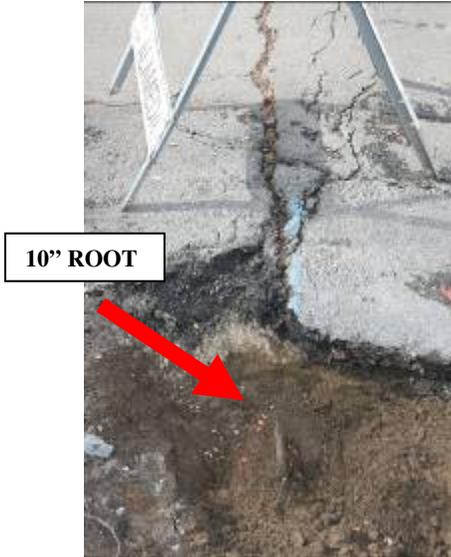
It does not appear that the tree can be retained due to the need to cut the large root growing under the street. This root would be cut at a point well inside of the primary root plate¹.

¹ Primary Root Plate – A radial distance from the base of the tree equal to three times the tree diameter. Cutting roots inside of the primary root plate significantly increases the potential for root failure.

Photo 1. Photo to the left below shows the root (Red Arrow) that is growing under the street. Cutting this root will compromise the tree stability beyond acceptable limits.

It is recommended that this tree be removed and replaced prior to making street repairs.

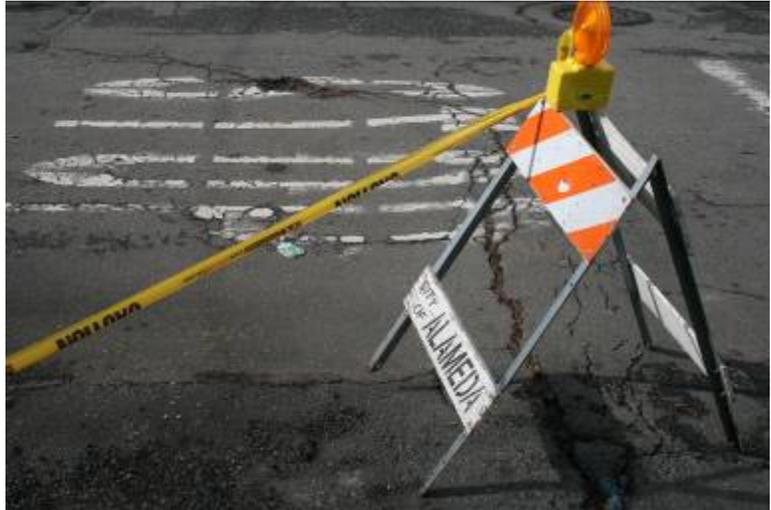
Photo 2. Photo above shows the uplifted street that extends well out to the center of the roadway. Only cutting the root will solve the problem.
