Steve Batchelder, Consulting Arborist
1534 Rose Street, Crockett, CA 94525
WC ISA Certified Arborist #228
Calif. Contractor Lic. (C-27) 533675
Phone (510) 787-3075, Fax (510) 787-3065
E-mail sbcatree@comcast.net

Date: June 1, 2007

Location: 1728 Chaplin

Subject: Root-Sidewalk Conflict

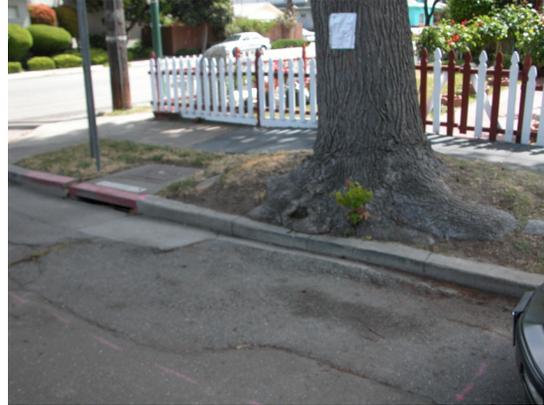
The curb has been depressed as a result of the weight of the tree that has grown on top of the curb. The tree has a lean toward the street that is consistent with the depressed curb. This is a possible indication that the tree lean has been increasing.

Photo 1. Photo shows the base of the liquidambar tree and the street uplift. The rootcrown has grown out over the curb that is being depressed by the weight of the tree.

It is recommended that consideration be given to removal and replacement of this tree. The replacement tree should be a smaller stature tree and be planted farther away from the storm drain.

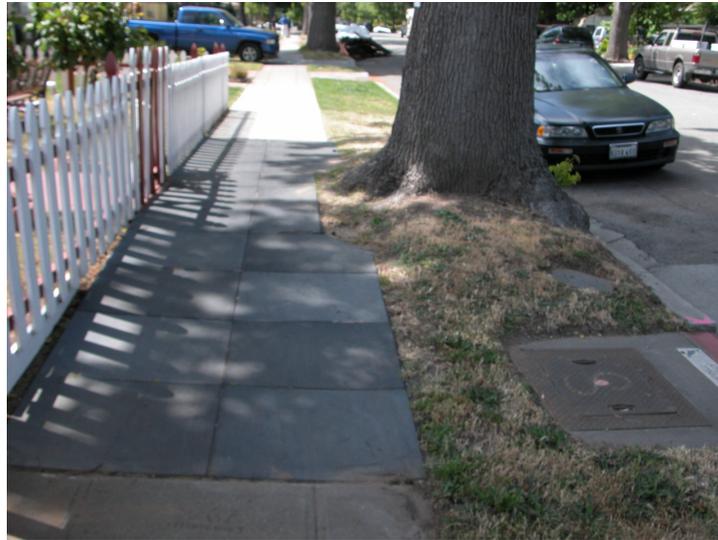
Photo 2. Photo to the right shows the parkway planting strip and the rubber sidewalk that has been used to accommodate the ever expanding roots of the liquidambar tree.

The lean into the street is evident and is likely causing the depression in the curb.
