SBCA TREE CONSULTING

Locations: 1728 Chapin

Subject: Safety condition of liquidambar tree

Assignment: I was asked to inspect the tree after a recent stem failure causing damage to an adjacent residential structure.

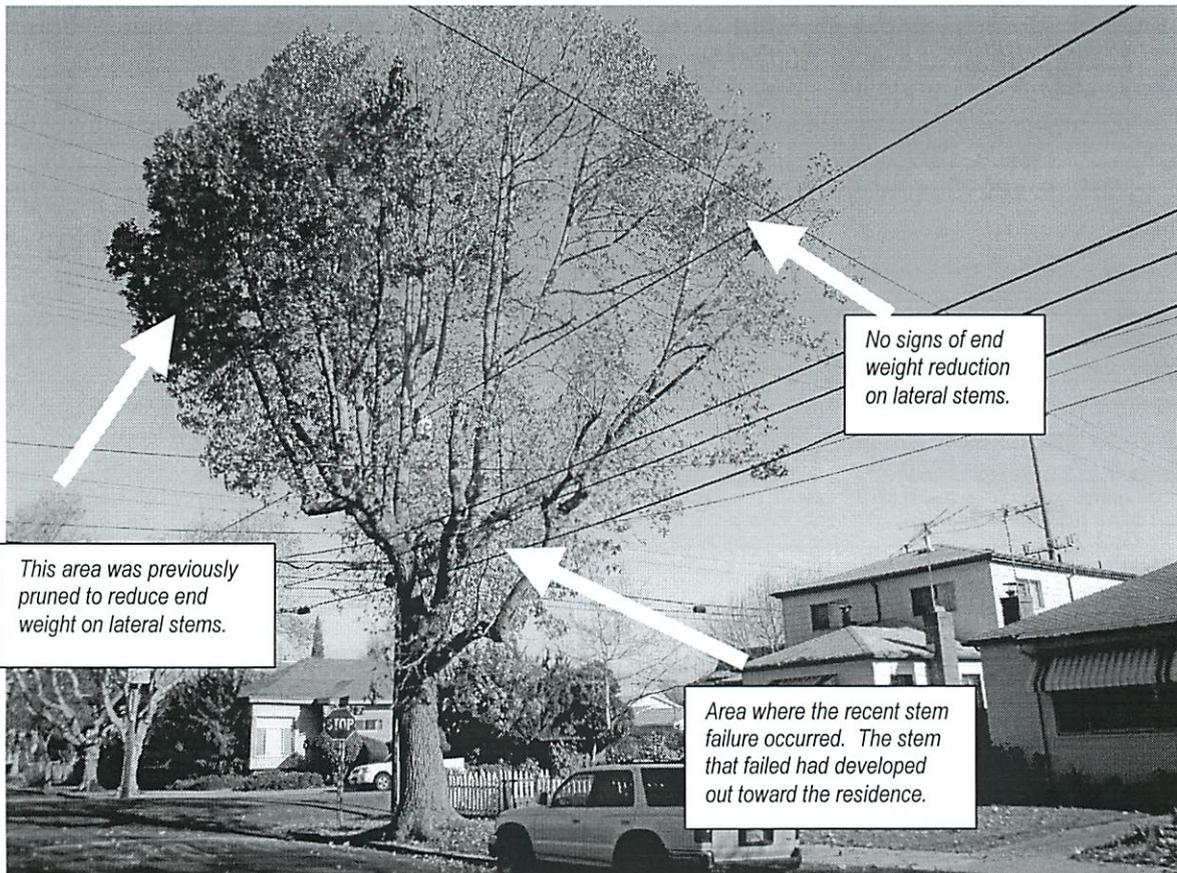
The tree has a DBH of 34 ½ inches and is approximately 65 feet tall with a 55 foot spread. The limb that failed has been headed back of the break location and no evidence of the break was available.

Having reviewed other arborist documents and spoken with Aaron, it appears that there are a number of possible reasons for the failure. In all cases, stem failure potential could have been significantly reduced through timely pruning to reduce branch "end weight"².

Photo below shows the tree. Arrow points to the location where the stem failure occurred. The left side of the tree has received pruning to reduce lateral stem weight. The right side where the stem failure occurred has fewer indications of pruning to reduce lateral stem weight.

1. Set up an annual monitoring of a large liquidambar trees.
2. Assign a failure potential to all trees.
3. Adopt a five-year pruning cycle for all problematic liquidambar trees. Pruning crew must also monitor the level of decay in the stems.
4. Prune to reduce lateral stem weight and length. Do not to reduce height on an upright stem unless necessitated by attachment angle or level of decay. The liquidambar tree grows to only about 70 feet so it is not necessary to head back the more upright stems in the center of the crown. Stems that have developed more laterally on the perimeter of the crown end weight reduction. Such a procedure reduces the overall length of the stem and reduces overall foliage in the outer 1/3 of the stem through pruning that utilizes only "thinning cuts"³.
