SBCA TREE CONSULTING

Date: November 14, 2014

Subject: Tree Safety

Location: Pacific Ave

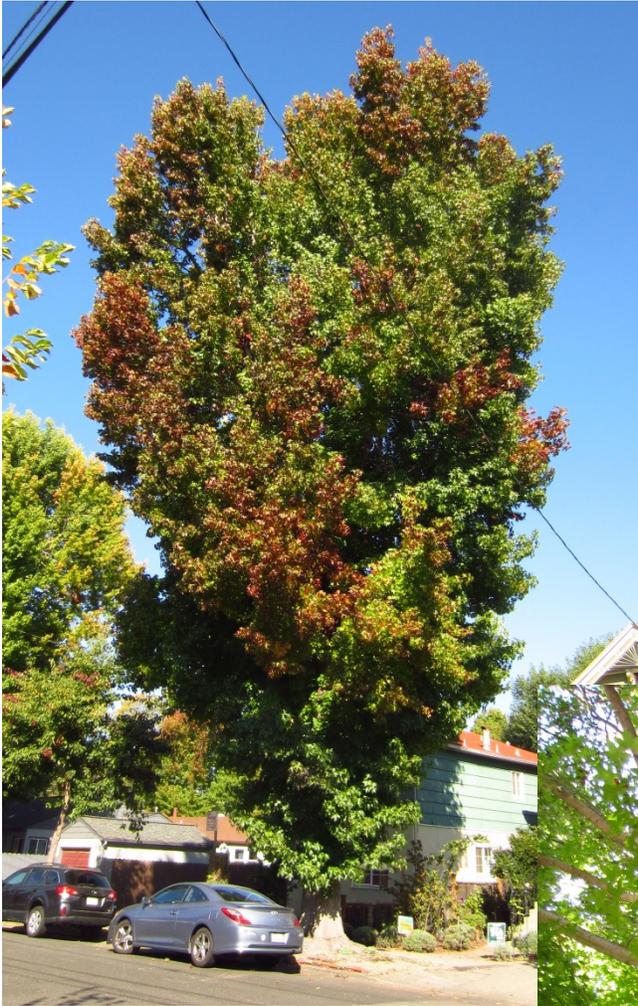
Photo 1. Photo to the left shows the tree in front of #1013 Pacific. This tree has been pruned properly; kept narrow to discourage heavy lateral growth that is prone to breakout. Some reduction on the lateral limbs over sidewalk (not pictured) is recommended for this tree during the next pruning cycle. Large old trees such as this generally require pruning maintenance a five year intervals.

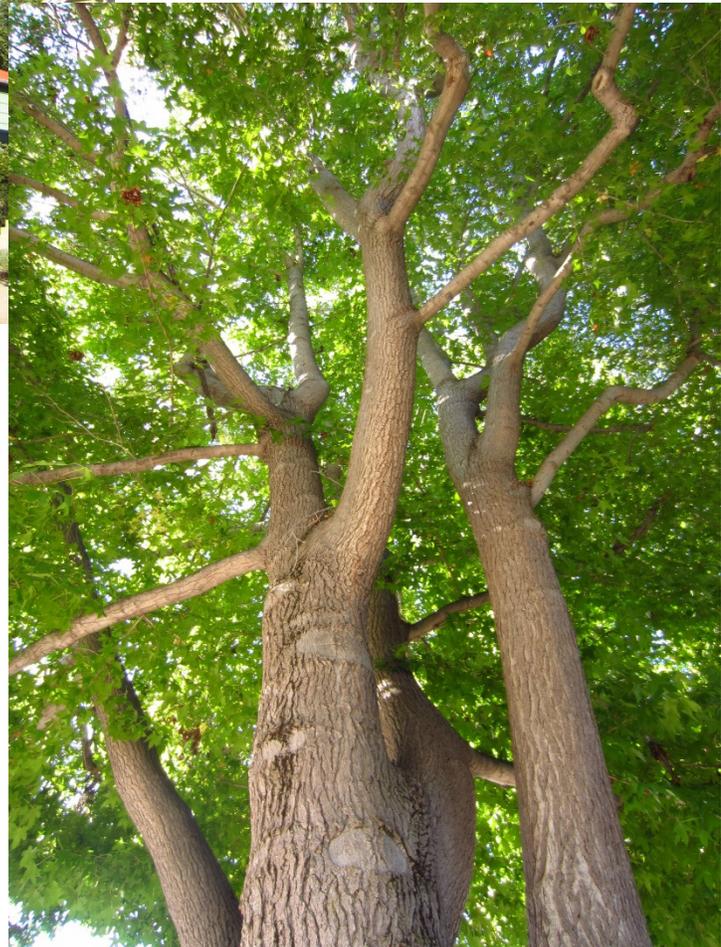
Photo 2. Photo to the left shows side tree #3 at 1700 Chapin. Past pruning has not compromised the present safety of this tree. Most of the structurally problematic trees did not receive the pruning this tree received. The relatively brash wood of the Liquidambar tree does require that lateral stems be balanced and not allowed to spread excessively to reduce twisting and branch end weight.

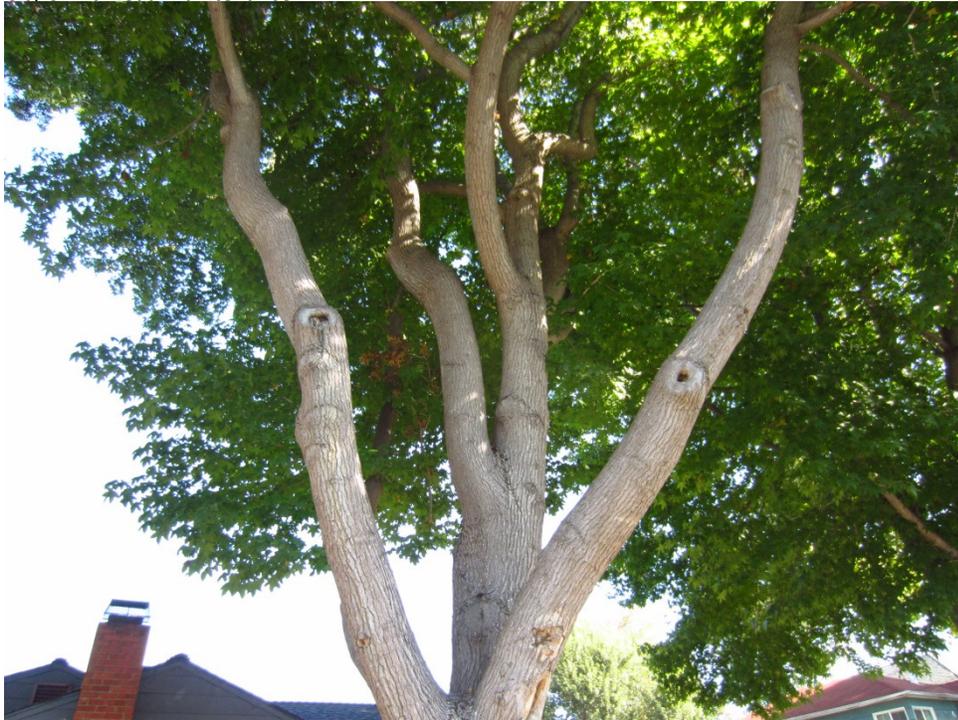
Photo 3. Photo to side tree #2 at 1700 Chapin. Stem codominance can be addressed through pruning only one of the two stems. Past pruning removed larger limbs on the street side leading to decay cavities seen. These areas should be investigated prior to pruning.

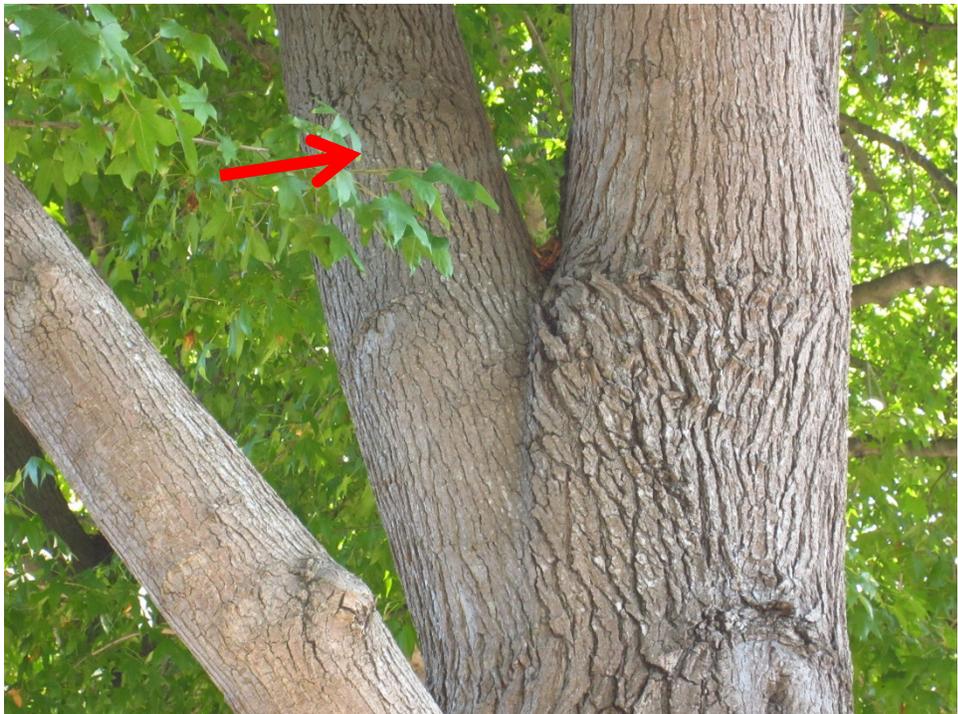
Photo 4. Photo to the left shows the codominant stem attachment with included bark noted on side tree #2 at 1700 Pacific. The safety concern is reduced slightly due to the vertical growth of the stems. It is recommended that one stem (red arrow) be pruned more heavily to reduce the level of codominance. Pruning cuts should be no larger than 4" in diameter.

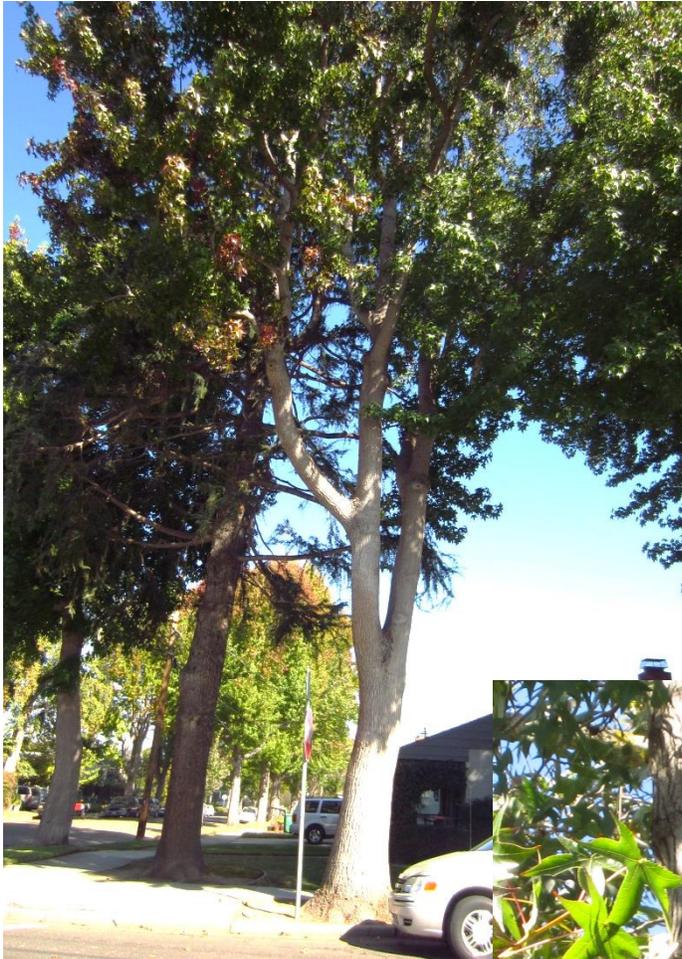
Photo 5. Photo to the left shows side tree #1 at 1700 Chapin. This tree's codominance can be addressed with end weight reduction on one of the main stems. Trees with one central leader have a stronger structure than trees with multiple leaders. Some areas of suspected decay can be observed.

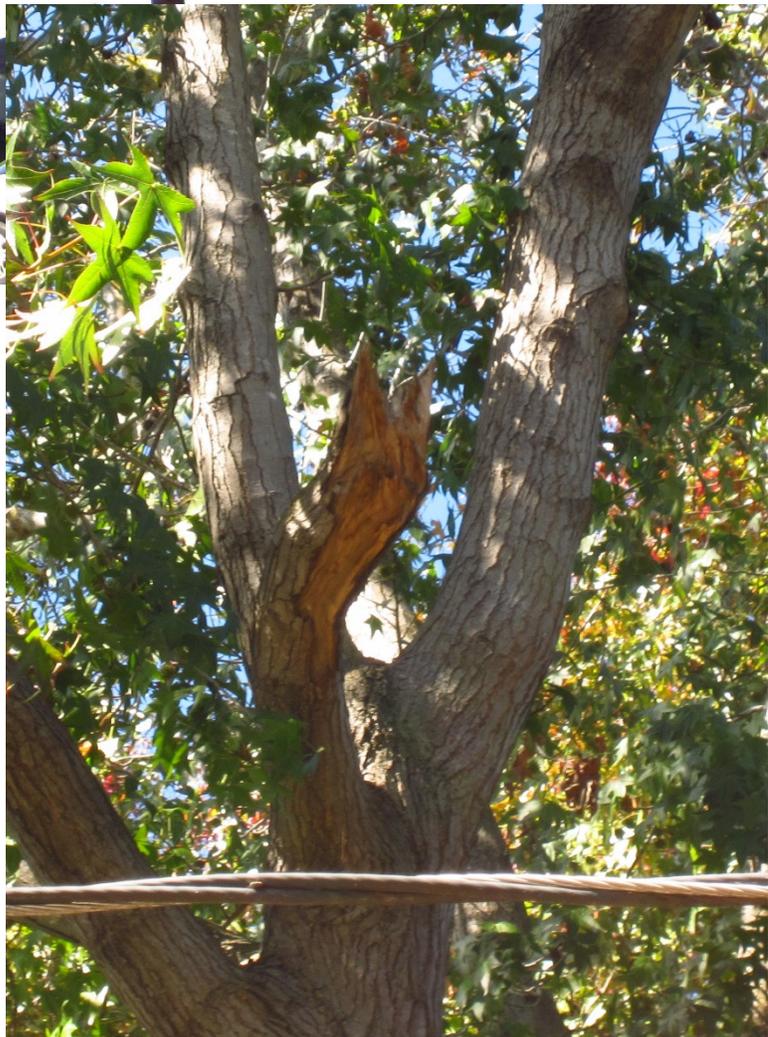
Photo 6. Photo to the left shows the eastern tree at 951 Pacific. The tree has suffered a large breakout likely due to excess end weight coupled with twisting from an unbalanced limb. Pruning to reduce branch end weight and balancing the weight can mitigate concerns for these types of failures.

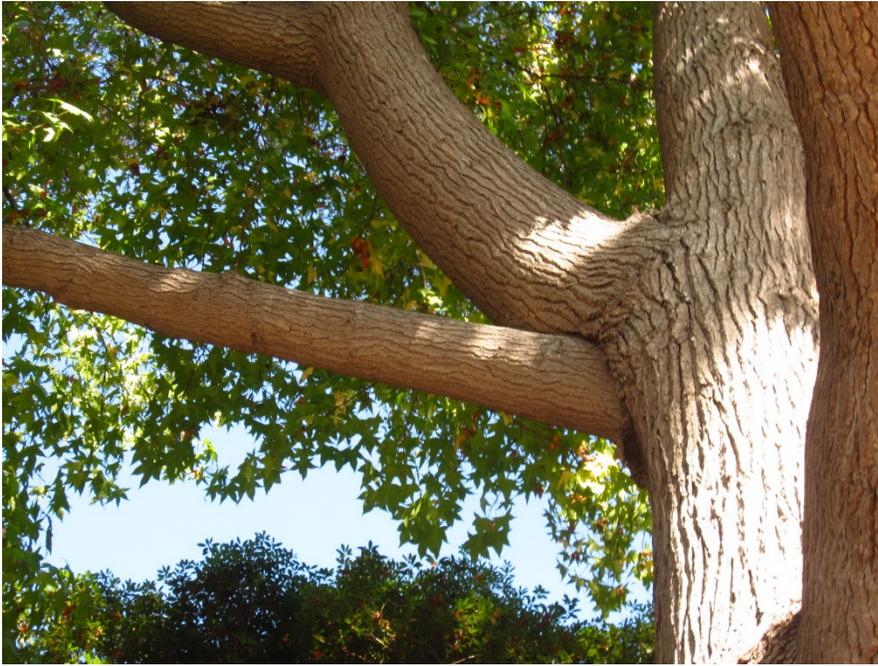
Photo 7. Photo to the left shows a lateral branch with an included bark stem attachment on the western tree at 951 Pacific. This limb should be reduced to slow growth and reduce weight. Although it may be quicker and cheaper to remove this limb entirely, it is not recommended as larger pruning wounds lead to decay in time.

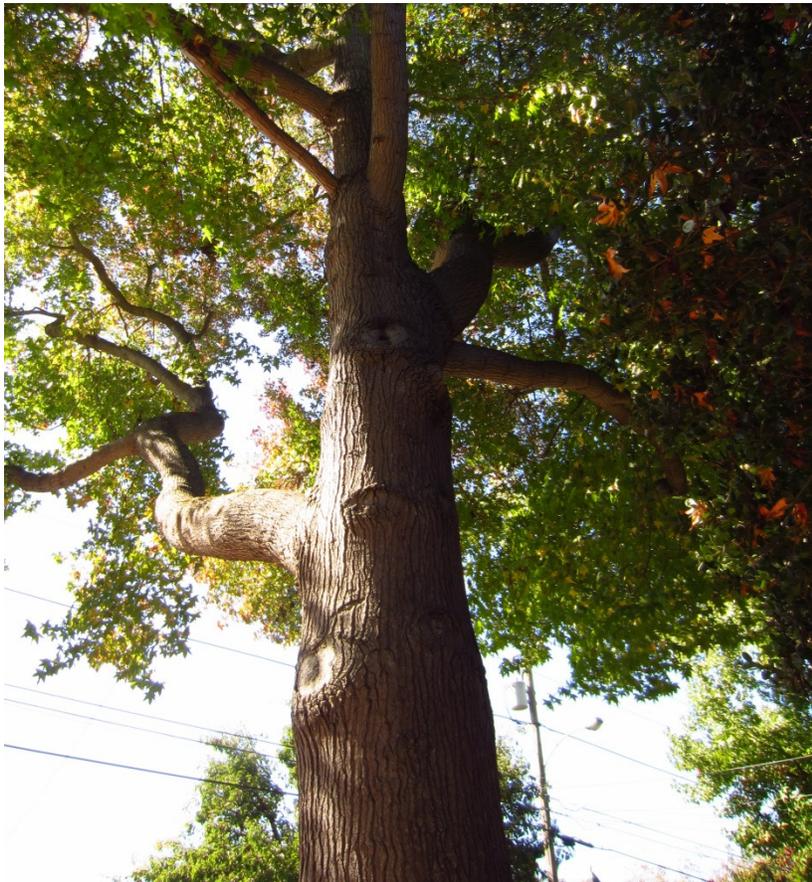
Photo 8. Photo to the left shows the trunk of the western tree at 951 Pacific. The large pruning wounds on the trunk have since closed, but sounding with a mallet indicated internal decay in present but likely not excessive. Advanced decay assessment is recommended for this large tree.

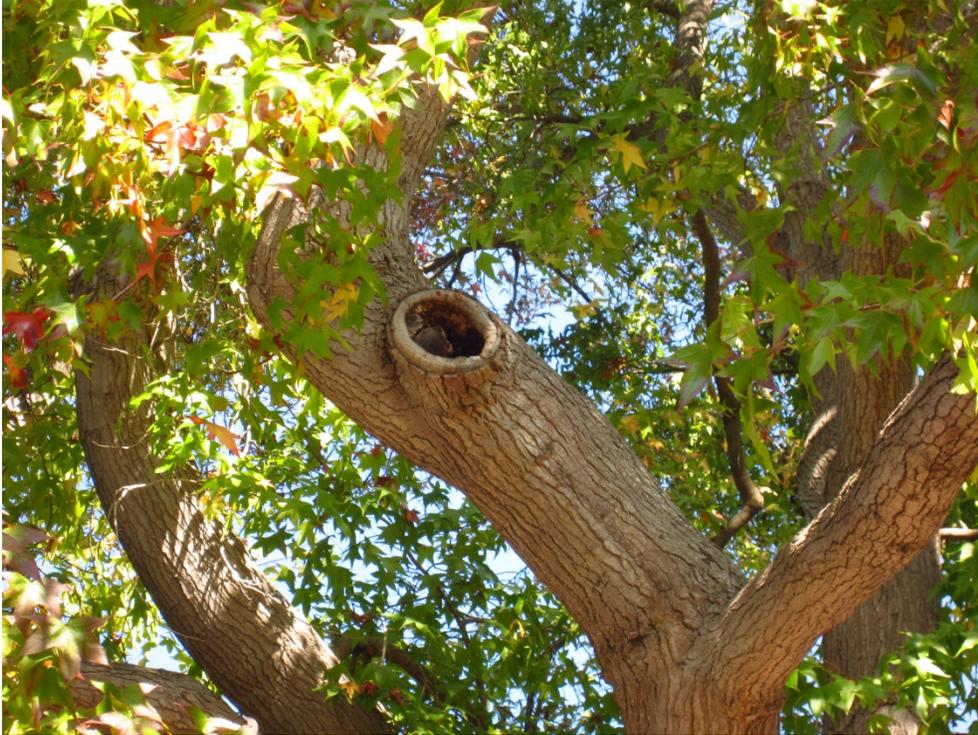
Photo 9. Photo to the left shows western tree at 951 Pacific. A large decay pocket is present on this unbalanced branch. Advanced decay assessment is again recommended. Lateral weight reduction should be best administered to all stems exhibiting these types of defects.

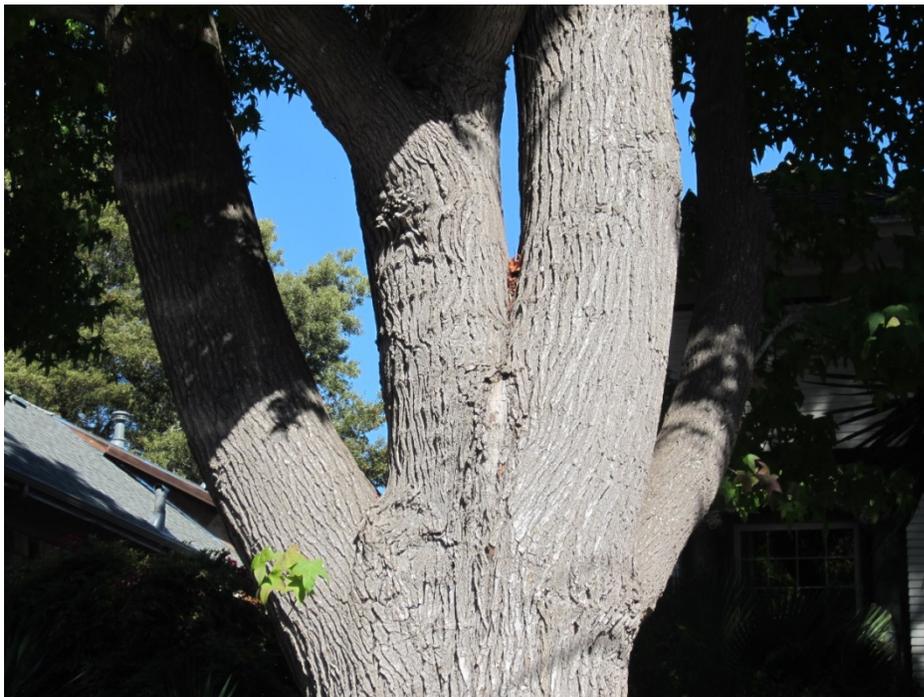
- **Tree Removal** – As part of good urban management to remove and replace of the most problematic trees and trees that require the most amount of maintenance to retain, it is recommended that Tree #7 at 943 Pacific be removed due to the significant codominant-included bark defect. The attachment shows signs of internal cracking.

Address	DBH	Health	Structure	Notes	Recommendations
7	943 Pacific	33"	G	P	Codominant with included bark with signs of internal cracking; Large pruning wounds on laterals over street with decay; Curb displacement; Minor sidewalk displacement; Circling girdling roots	Remove Tree

Photo 10. Photo shows tree at 943 Pacific. Co-dominance and included bark defects are present. There are signs indicating that the internal cracking is advancing. This tree is a candidate for removal but pruning can severe reduction pruning can mitigate immediate safety concerns.

Option #1, Tree Removal – It is recommended that Tree #7 (943 Pacific) be removed as part of good urban forest management.

Option #2, Crown Reduction – If Tree #7 cannot be removed in a timely manner, severe crown reduction can be applied to mitigate immediate safety concerns. Pruning must satisfy the safety concerns based upon the aerial inspection. Both the amount of pruning and the size of the average pruning wounds must be designated by an arborist prior to beginning.
