Alameda Elks Lodge 1015

DRAWING TITLE
**SITE PLAN,
(E) BLDG. DEMO
AREA, NOTES**

Re: Permit B13-0211, Lodge Building, 2255 Santa Clara Avenue

At the request of the Elks Hall Association of Alameda, on May 8, 2013 we performed a structural engineering inspection of the referenced one story wood frame building. A demolition permit was recently issued and a stop work order was subsequently placed due to community concerns. The purpose of our inspection was to review structural condition and render findings and opinions.

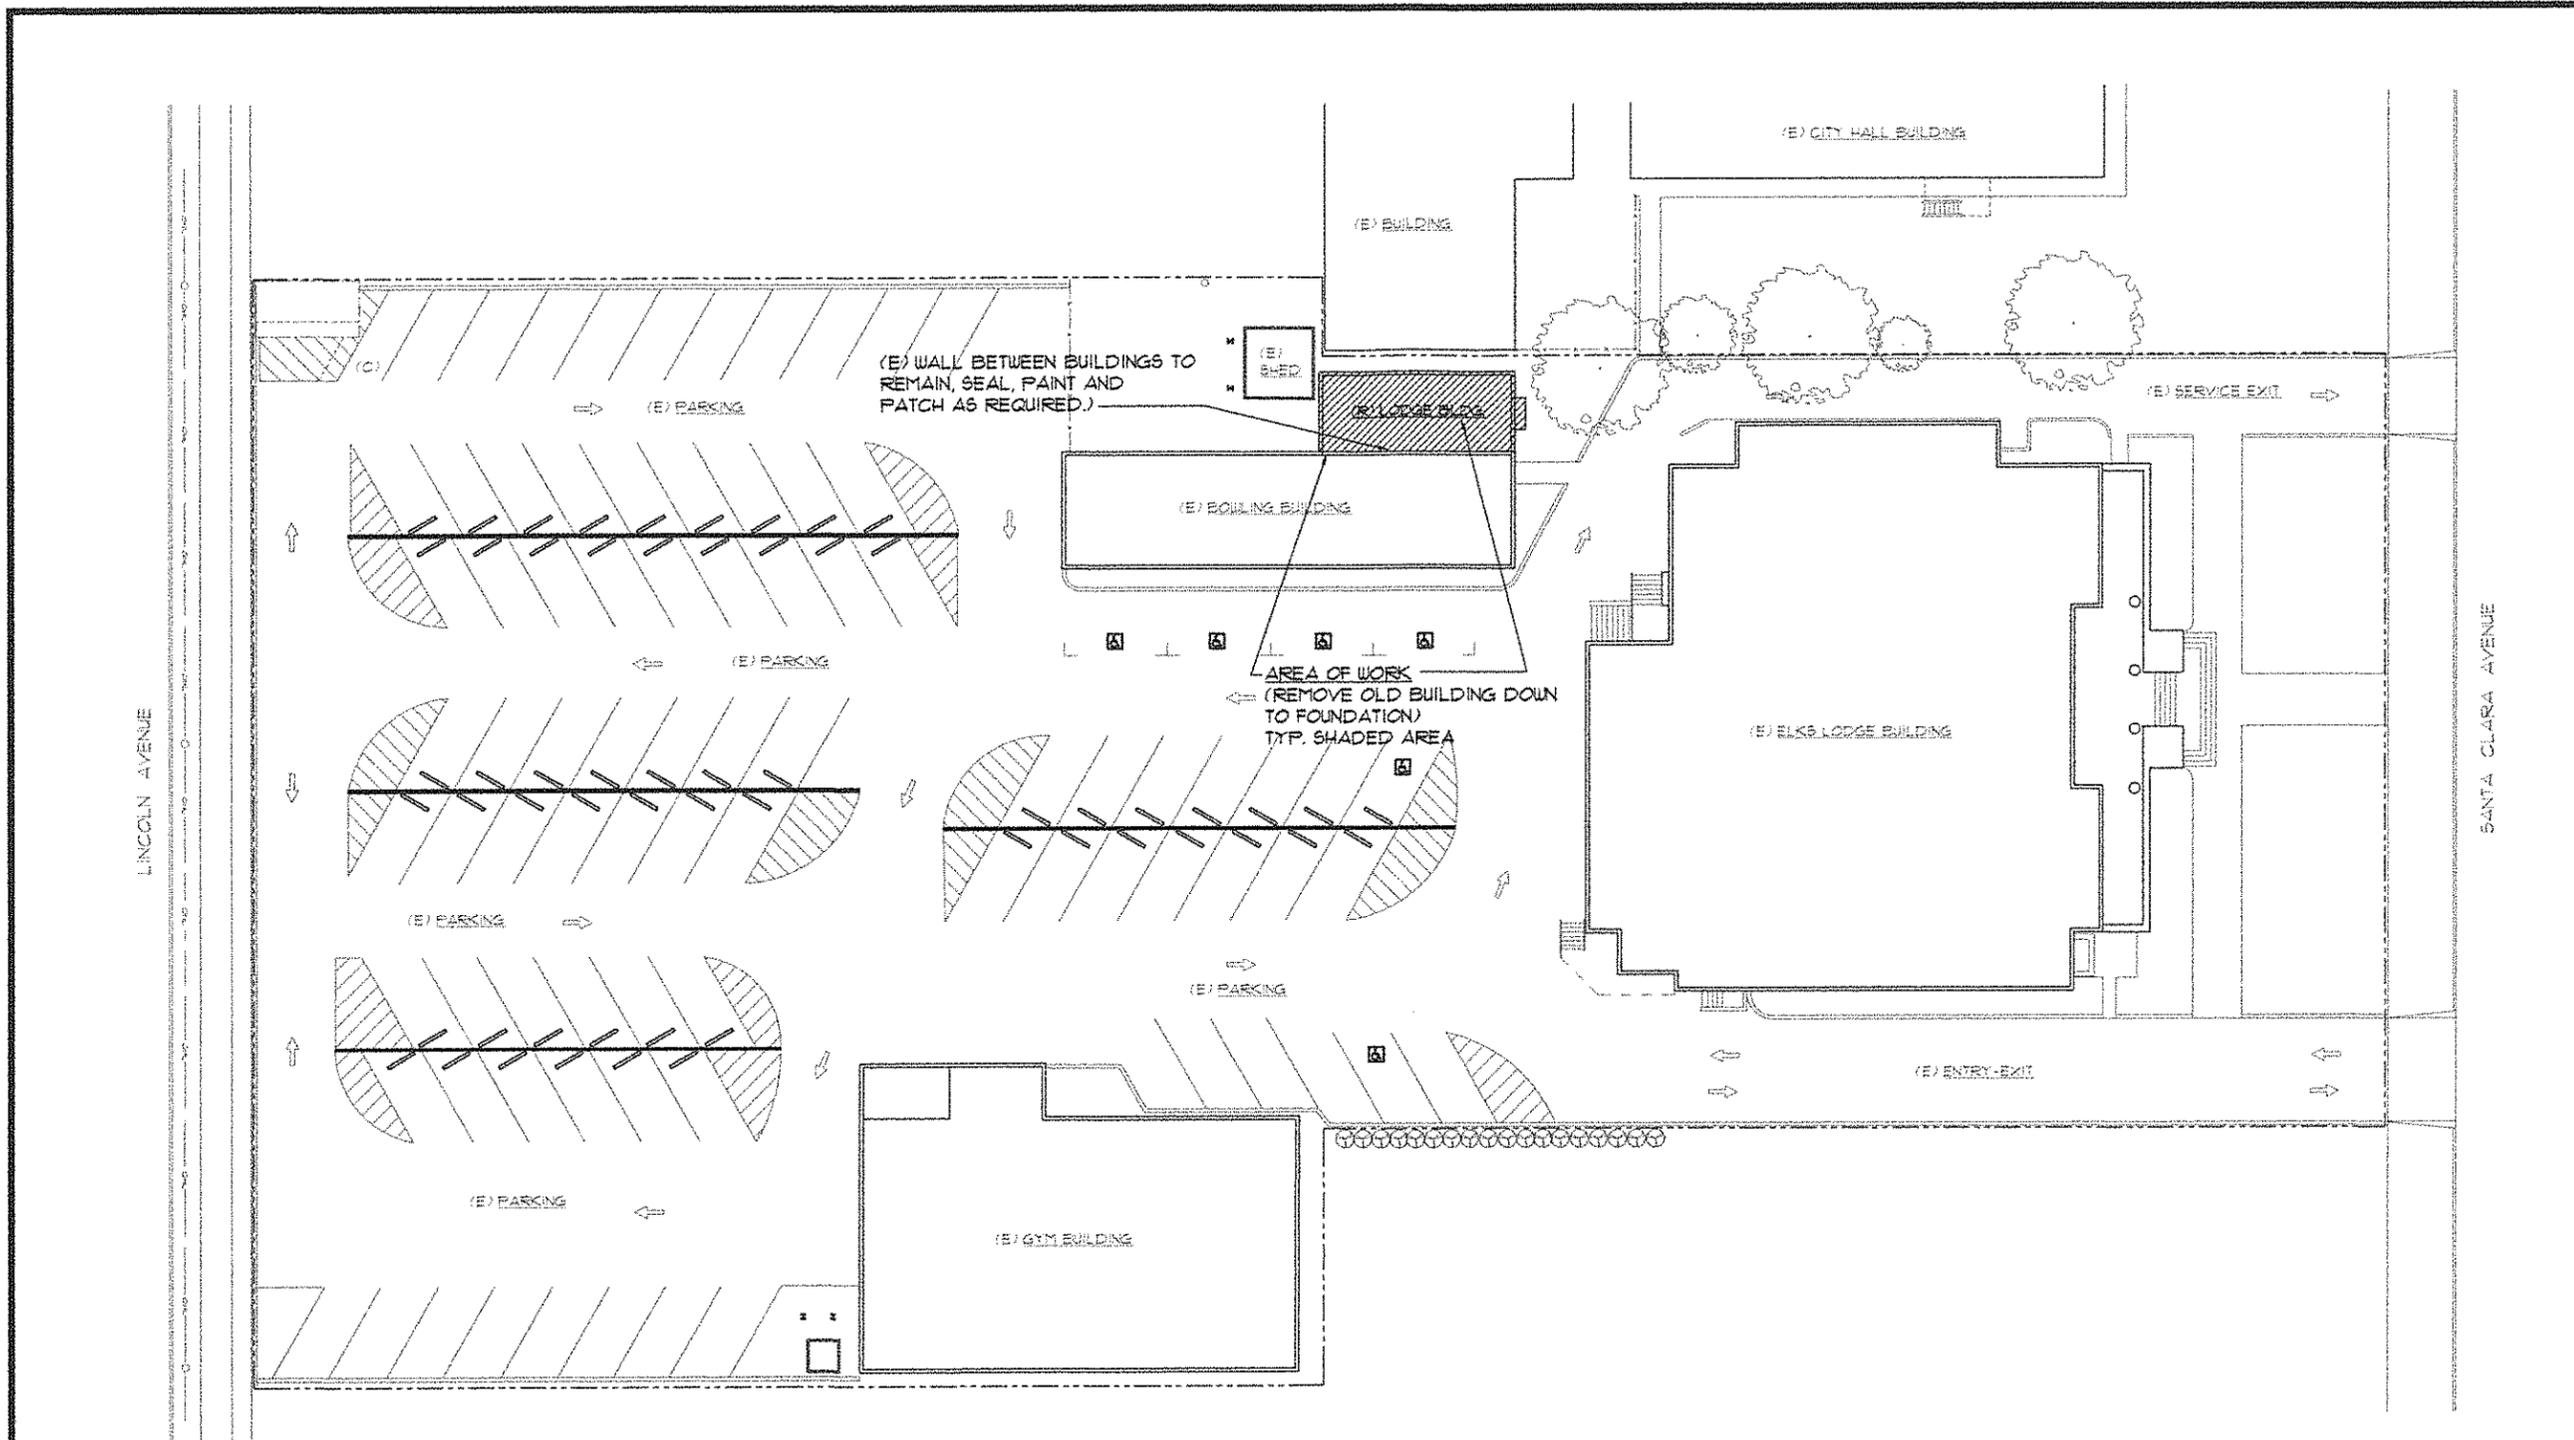
OLD BLDG. DEMOLITION PLAN
SCALE: 1/16"=1'-0"

(E) Bldg. Area Demolition

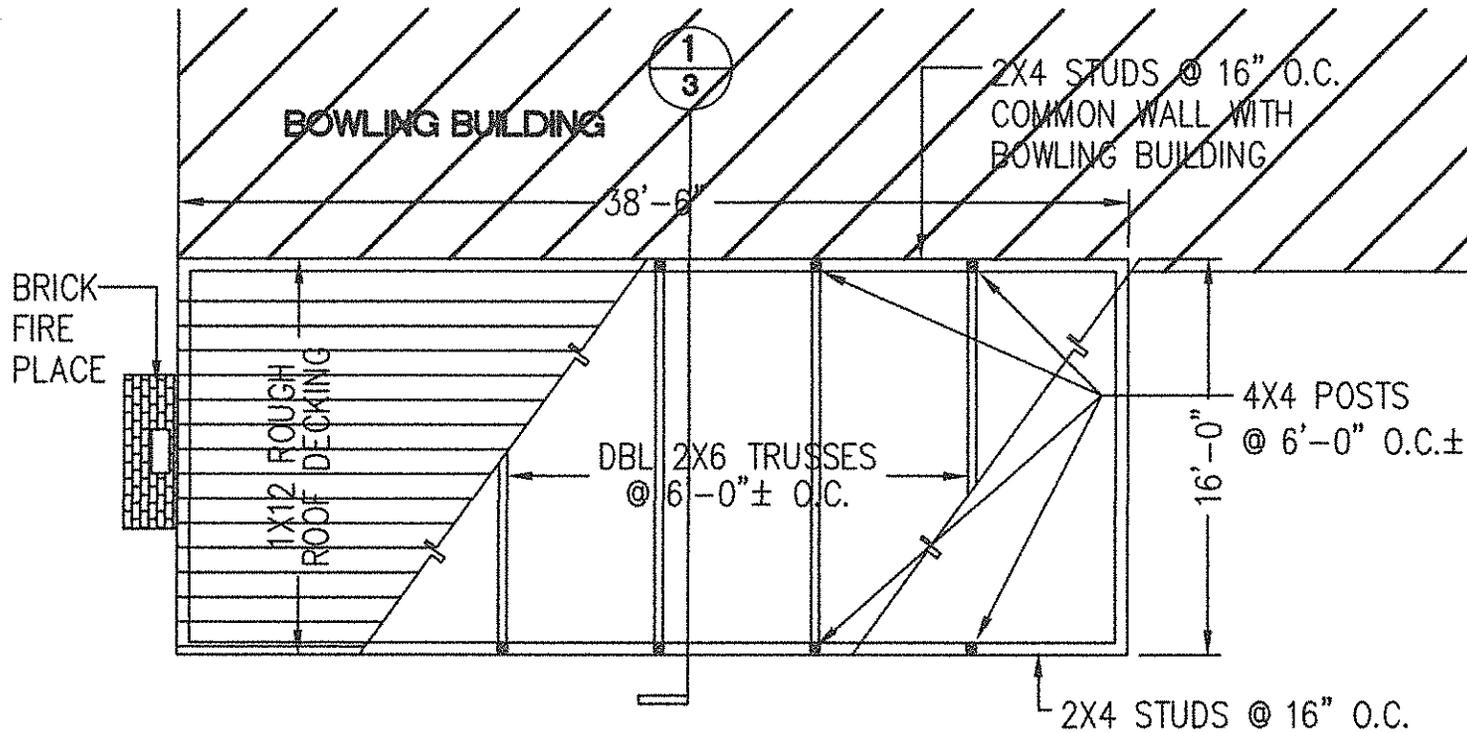
ROOF FRAMING PLAN

As shown on the attached three 8-1/2X11 sketches, the building's roof is framed with wood roof trusses bearing on 4X4 wood posts; half of which are buried in the ground. 2X6 wood sleepers support the floor and many rest in the ground as well. All ground bearing members are completely rotted. The building's east wall has settled such that the east side is about one foot lower than the west.

The building has no vertical or lateral support systems because continuous load paths are not present. As such, it fails to comply with both life safety and collapse prevention standards as specified in ASCE 41-07.

Based on the above, Lodge Building is a safety hazard and we recommend that you either, (1) allow its immediate demolition or, (2) post it for non-occupancy (Municipal Code Section 13-12.5) as soon as possible.

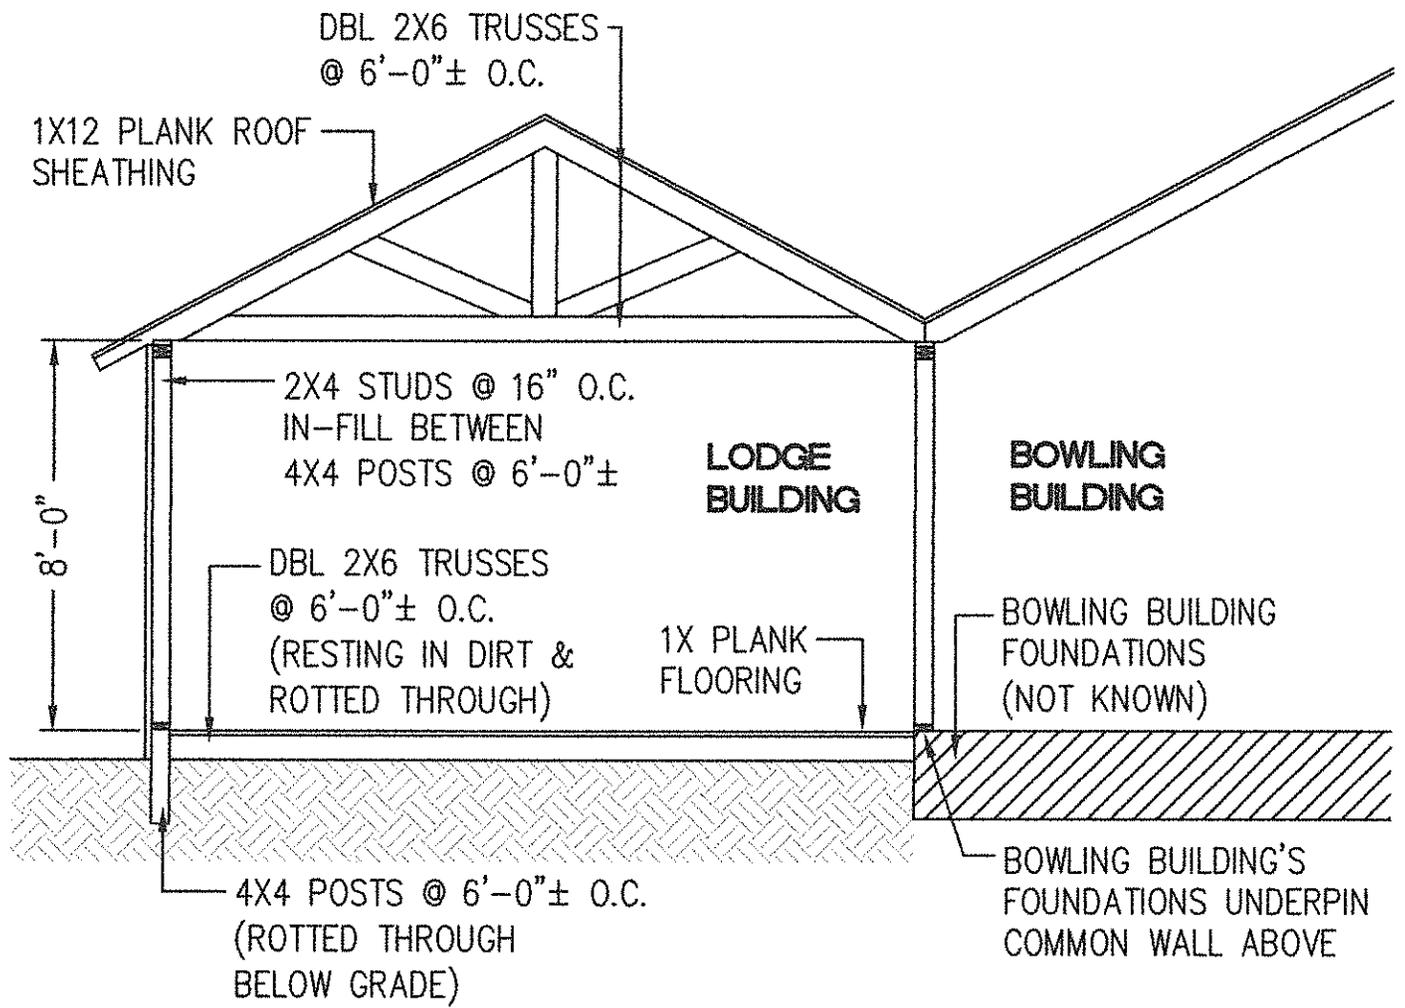
SECTION 1
3 $1/4"=1'-0"$

There is a large unreinforced brick masonry fireplace at the south end that has crumbled away over the years; the chimney has collapsed, but the hearth remains.

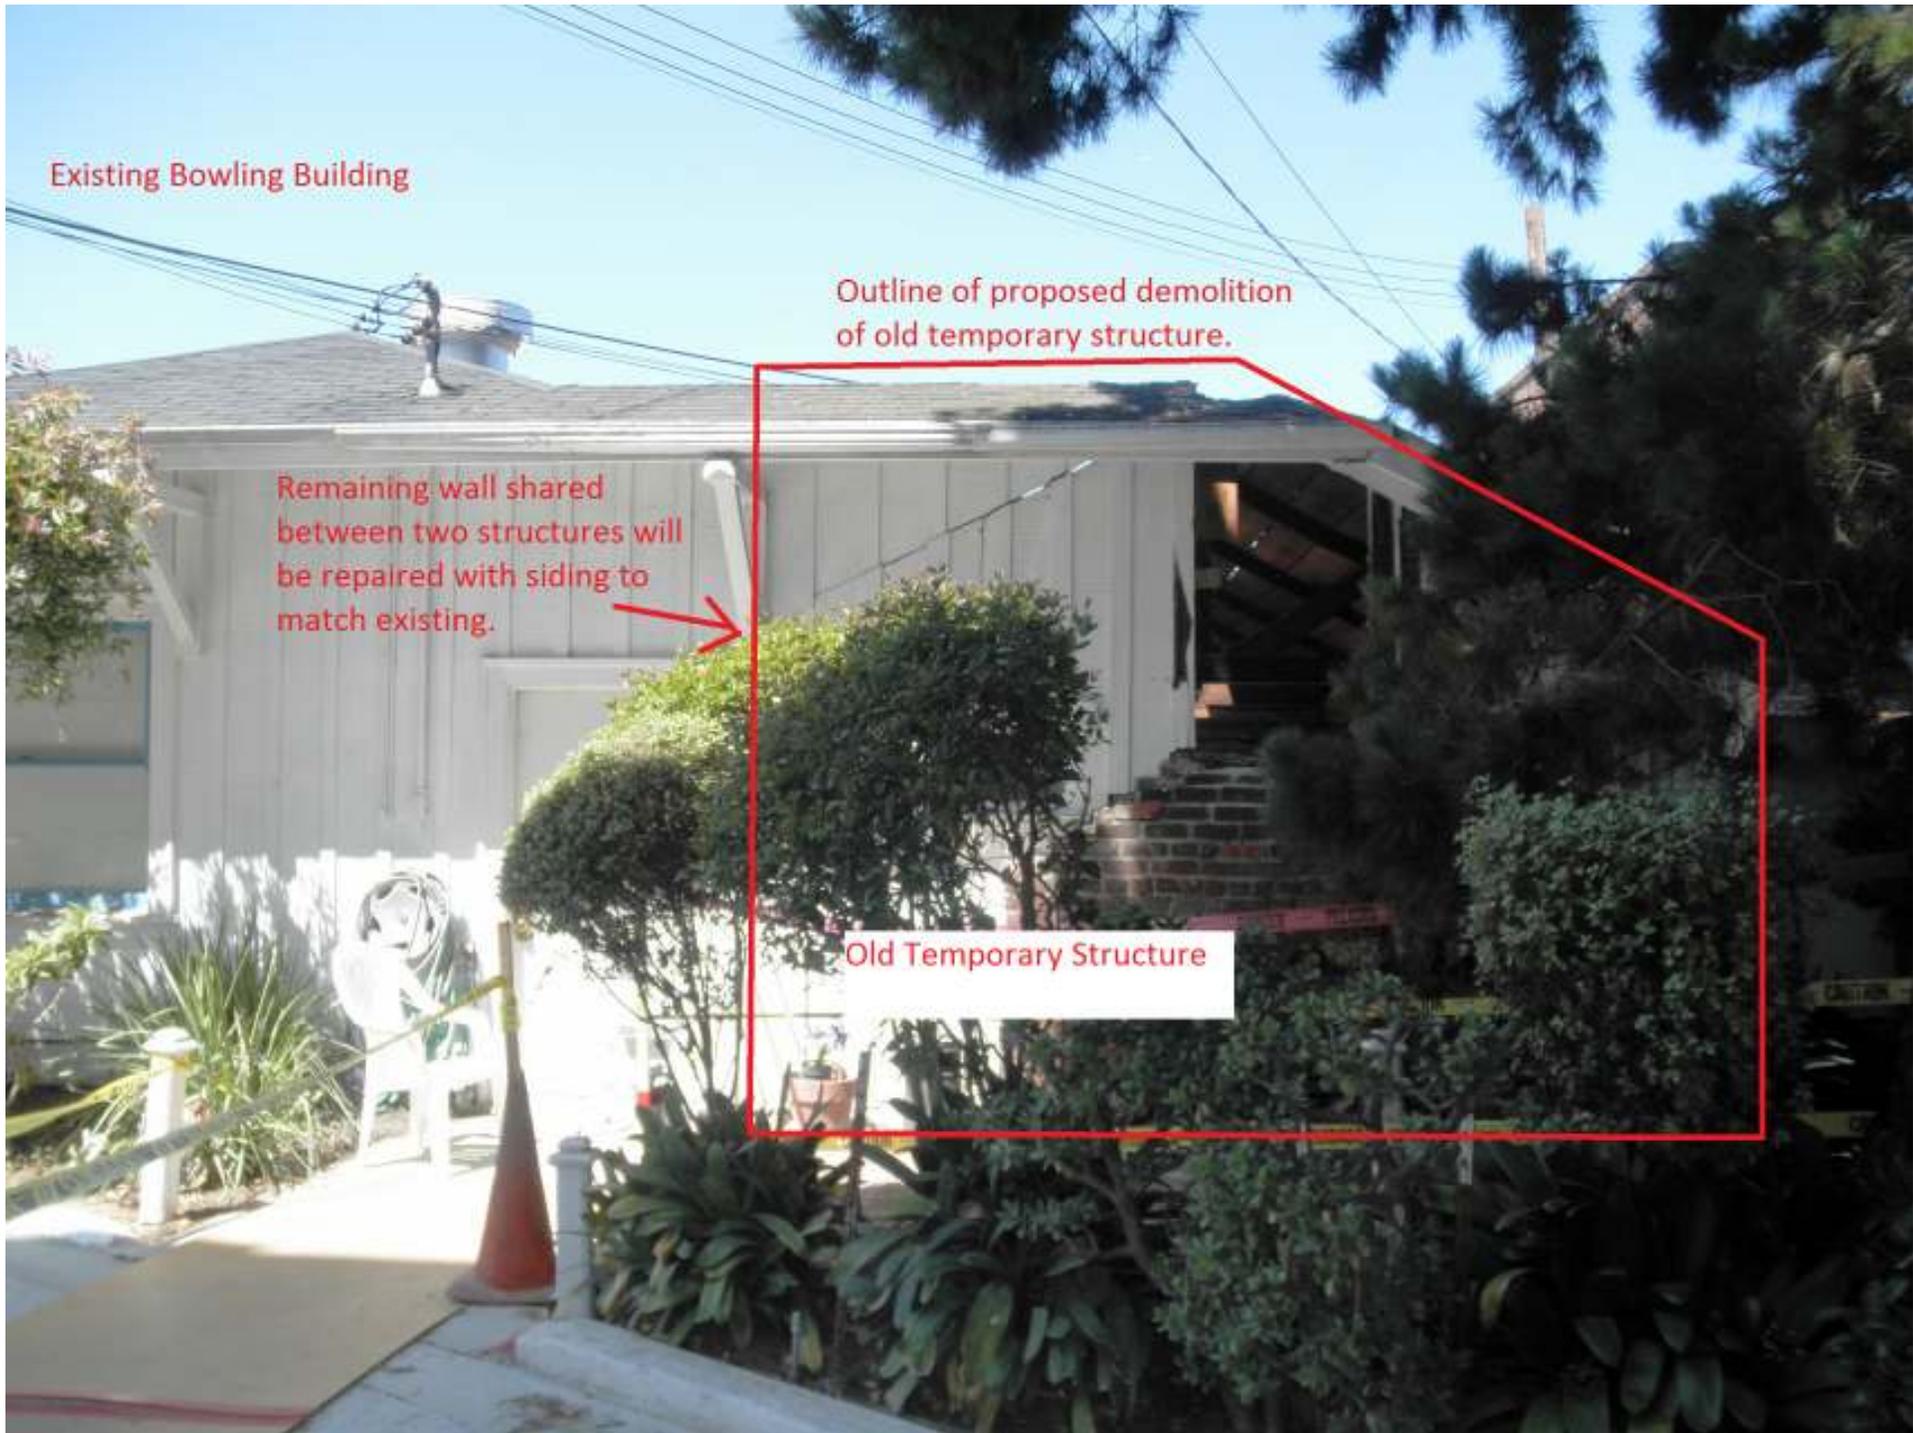
Existing Bowling Building

Outline of proposed demolition
of old temporary structure.

Old Temporary Structure

Remaining wall shared
between two structures will
be repaired with siding to
match existing.
