RE: Assessment of the City of Alameda Storm Drain Pump Stations

FINAL REPORT

STORM DRAIN PUMP STATION ASSESSMENT
CITY OF ALAMEDA

July 12, 2011

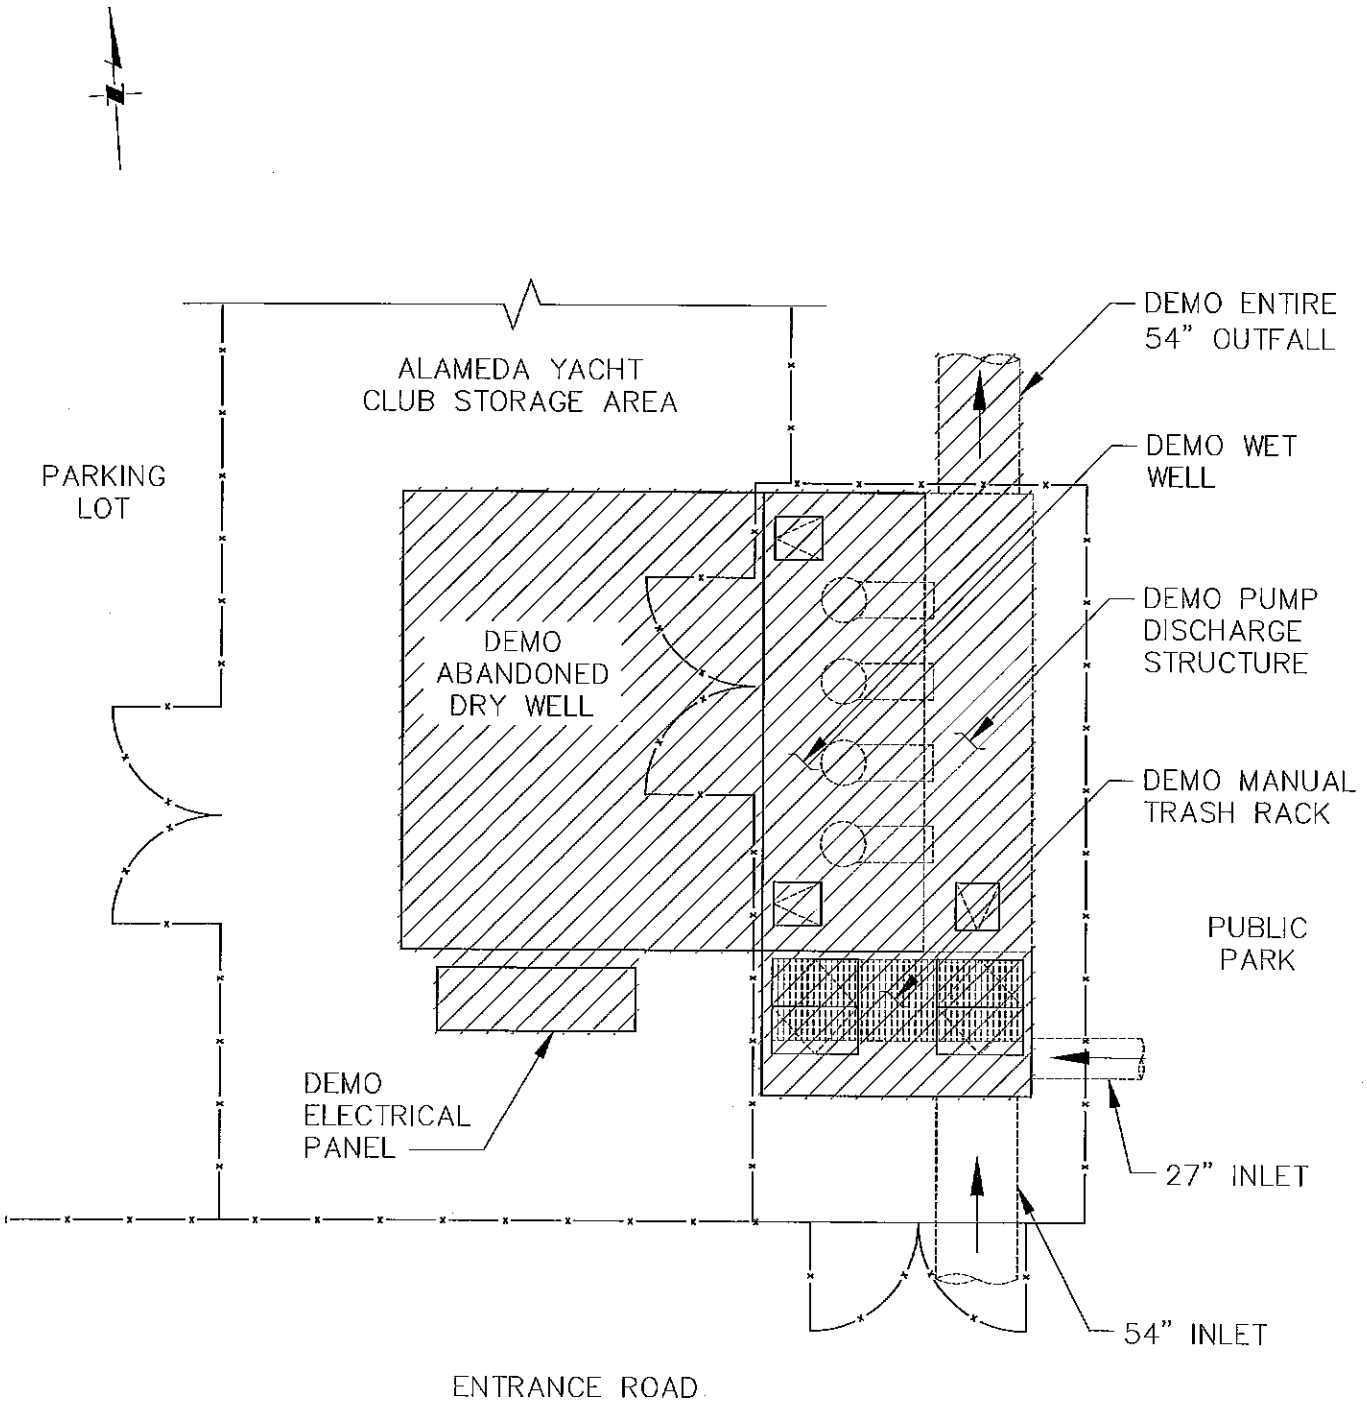
PSOMAS	CITY OF ALAMEDA STORM DRAIN PUMP STATION ASSESSMENT REPORT	EXISTING ARBOR PUMP STATION	FIGURE NO. 6-1 JOB NO. 6ALA010100

- Pumping capacity is inadequate to convey the design 10-year storm inflow.
- The existing pump barrel (30-inch) must be increased to 48-inch for the size pump required to convey the design storm water volume. The size of the station can not accommodate barrels of this size without compromising the integrity of the pump deck (only 6-inches of concrete would remain between pump barrels in the current configuration).

- The hydraulics of the pump station are not ideal. Influent enters the wet well perpendicular to the pumps and is not evenly distributed to the pumps. This can cause vortexing and/or other issues, which affects the efficiency of pump operation.

exceed to avoid flooding. A completely new pump station and upsized outfall (72-inches) is recommended for the following reasons:

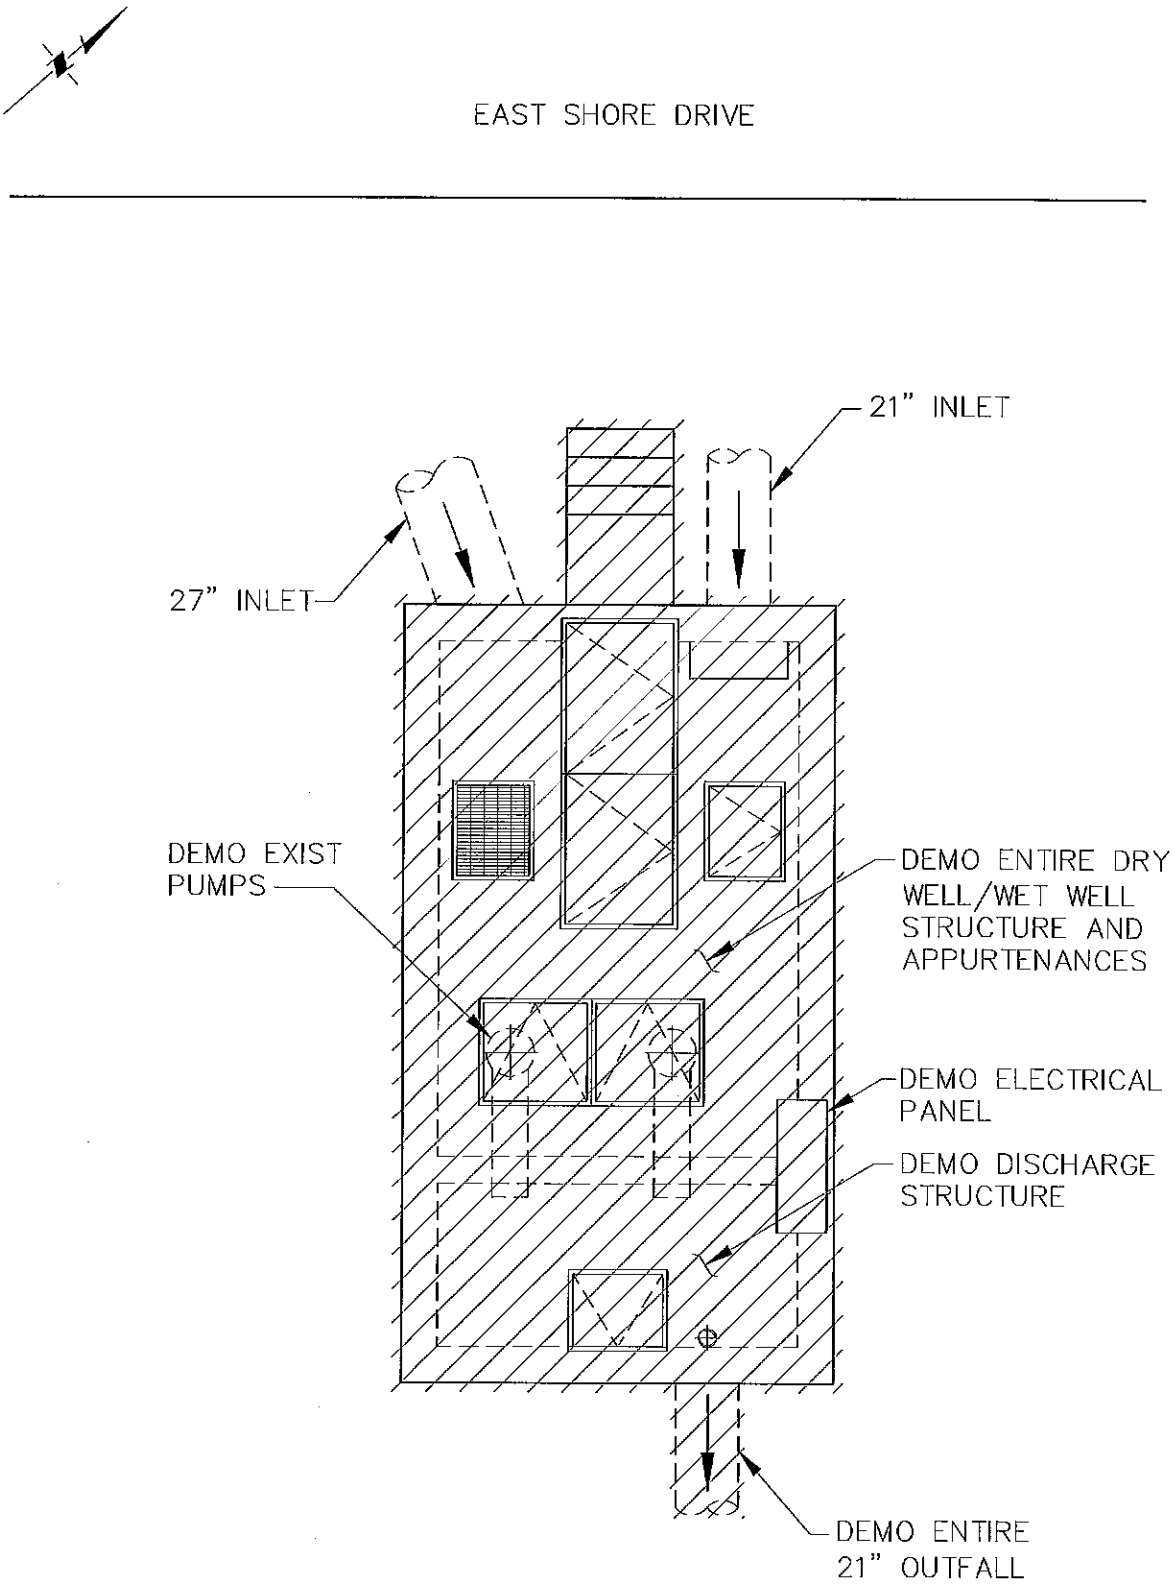
PSOMAS	CITY OF ALAMEDA STORM DRAIN PUMP STATION ASSESSMENT REPORT	EXISTING CENTRAL/EASTSHORE PUMP STATION	FIGURE NO. 6-3 JOB NO. 6ALA010100

- Installing larger openings in the pump deck is not possible due to the close proximity of openings to the discharge structure and wet well below the floor slab. A complete slab removal and replacement would likely be required to accommodate the larger submersible pumps which would require removing the existing concrete stairs and manual bar rack as well.

- Installing two rather than three pumps provides less reliable capacity in the event of a single pump failure (50 % versus 66.7 % reliable capacity). A minimum of three pumps is recommended where possible for each station. The existing wet well is too small to install three pumps.

New pumps are required to convey the design 10-year storm water volume of 19,750 gpm. A new larger outfall is therefore required to convey the design storm water volume. The outfall must be increased in size to 36-inches to convey this flow at a velocity of 7.0 feet per second or less. Figure 3-6 (Appendix B) shows system curves for an upsized 36-inch diameter outfall. A completely new pump station and upsized outfall (36-inches) is recommended for the following reasons:

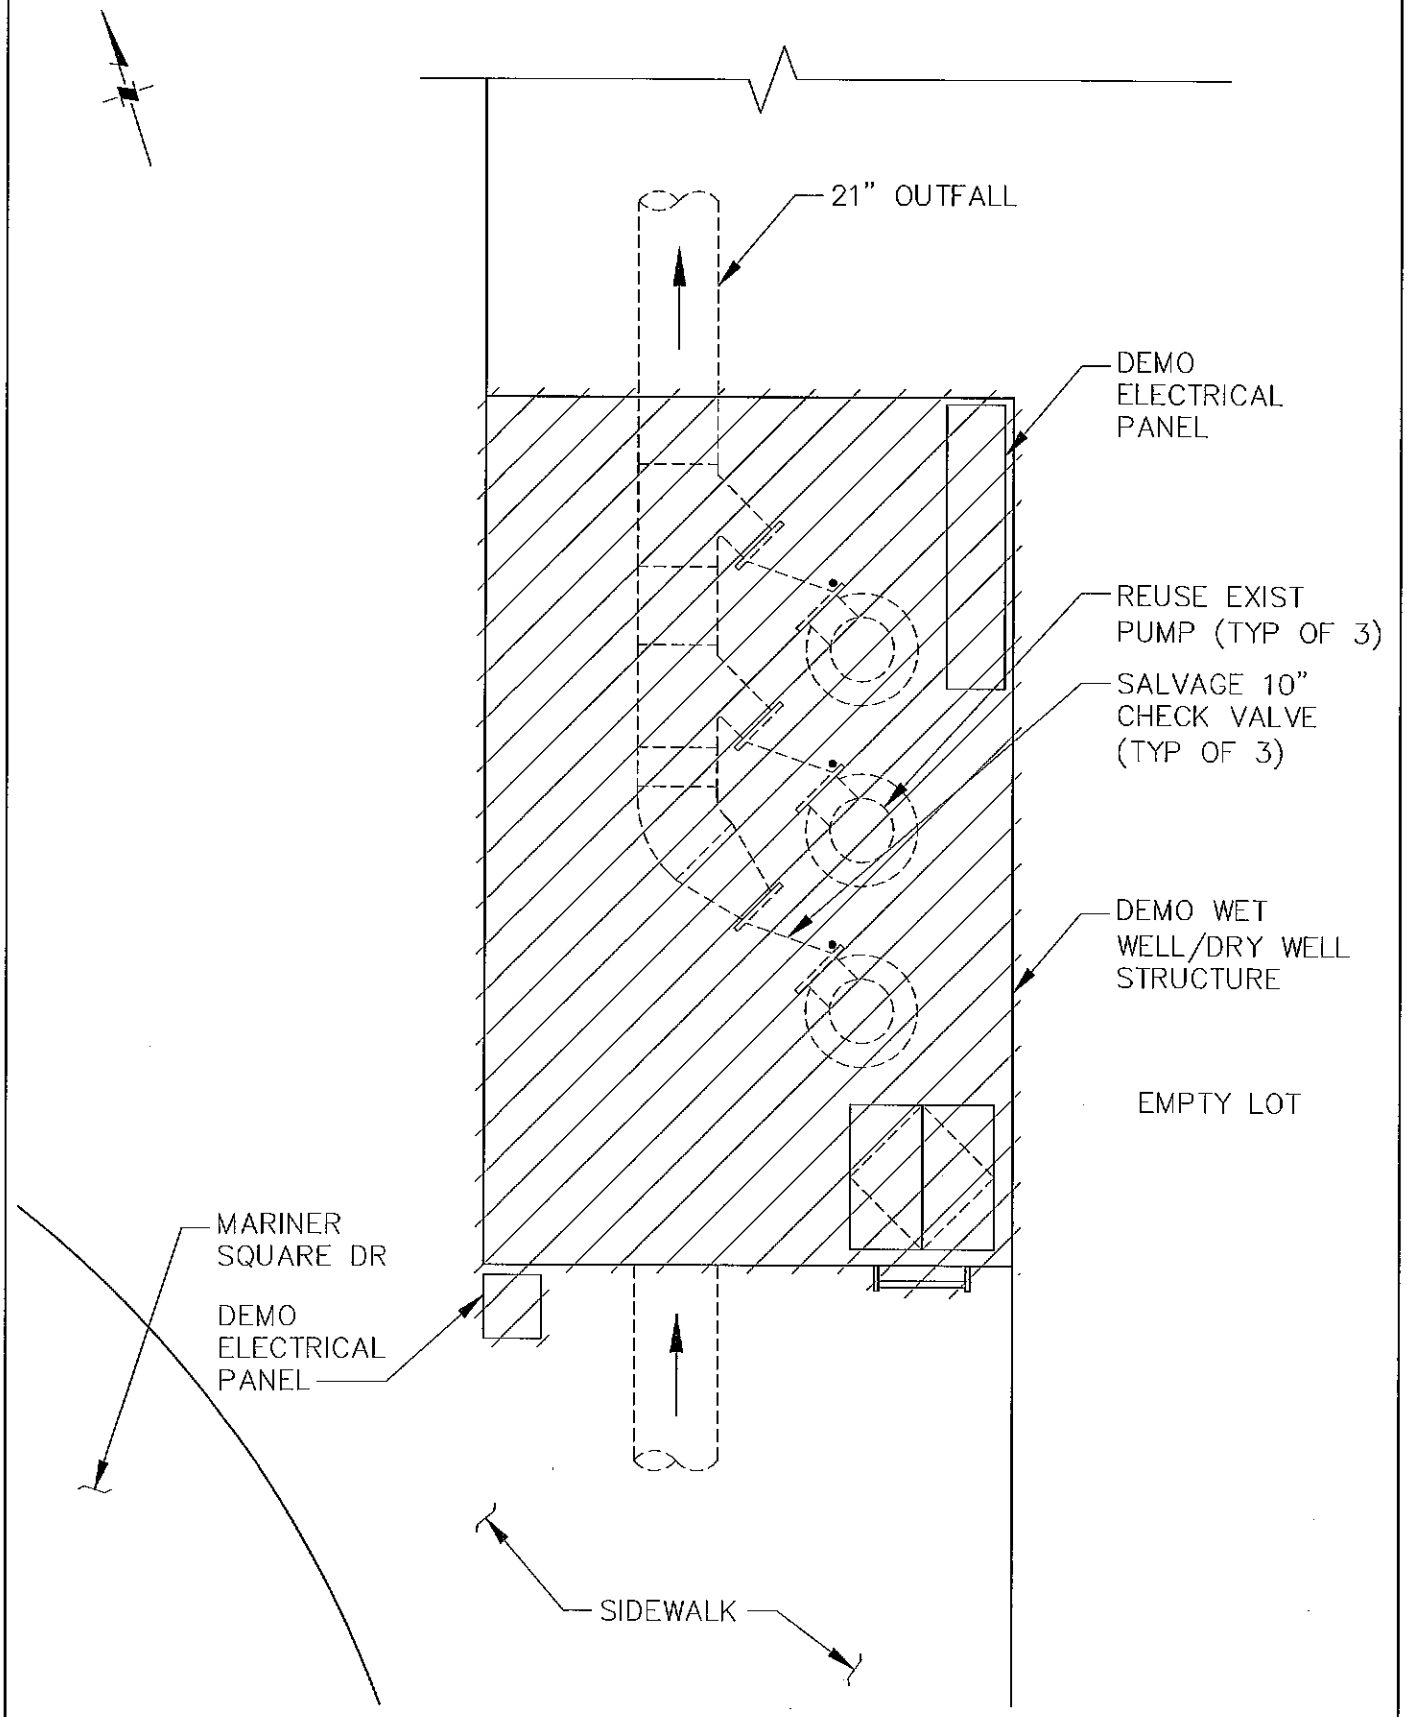
PSOMAS	CITY OF ALAMEDA STORM DRAIN PUMP STATION ASSESSMENT REPORT	EXISTING WEBSTER STREET PUMP STATION	FIGURE NO. 6-5 JOB NO. 6ALA010100

Although the pumps and forcemain capacity are sufficient for the design 10-year storm water flow at current 10-year and future high tides, a completely new pump station is recommended due to operations and maintenance and safety deficiencies at the station (see Chapter 5).

Pump Station	Summary of Recommended Improvements	Project Cost
Golf Course	Install exposed wiring in rigid conduit. Provide anti-slip surfacing on existing station floor as required. Install fire extinguisher.	$6,000
Main Street	Install Ladder and Handrailing. Install Ventilation in Wet Well. Install Fire Extinguisher. Install Anchors for Control Panel. Replace Pump Controller with Pump Vision Controller. Replace Existing Bubbler Level Controls with Pressure Level Transmitters.	$84,000
Northside	Replace pumps with new pumps capable of handling design stormwater flows. Replace checker plate with new plate as required to remove tripping hazards.	$587,000
Webster Street	Complete Pump Station Replacement to address operations and maintenance and safety concerns (Reuse Existing Pumps). Install Standby Generator and New Electrical Equipment. The Existing Webster Street Pump Station and Proposed Station are shown in Figures 6-5 and 6-6 respectively.	$1,043,000
