### 3.5. Character-Defining Elements of Building 17.

## 4. HANGARS AREA

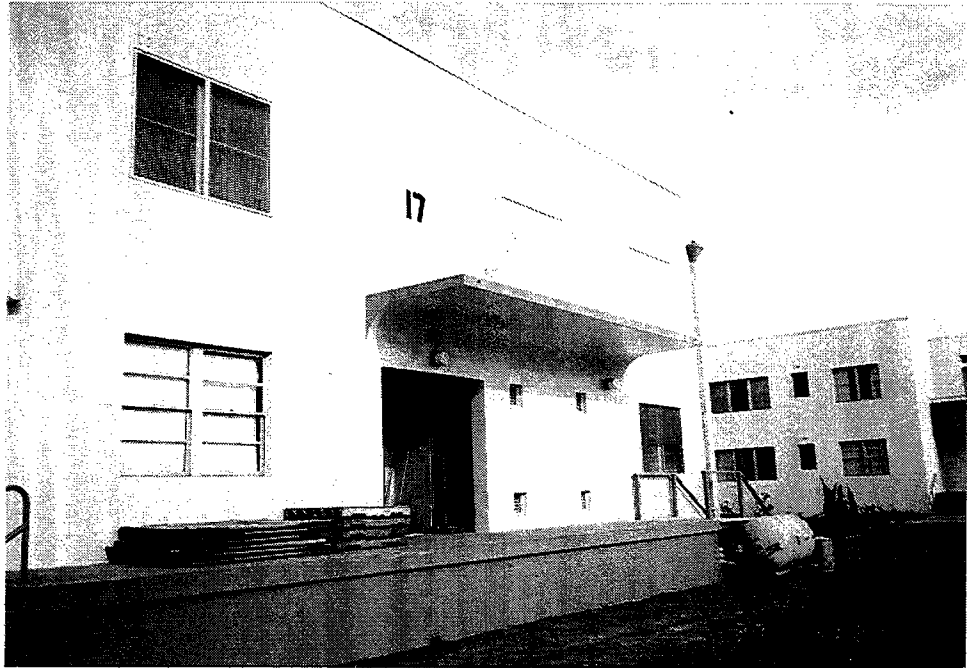
**Photograph 32.** Concrete canopy over loading dock of Building 17.

- Smooth concrete surface.
- Tall-two-story theater wing and low-slung post office wing.
- “Stacked” vertical element in theater wing (see Photograph 25).
- Arcade, including oval concrete columns, in post office wing (shown in Photograph 18).
- Original two-over-two wooden double-hung sash in mail sorting area of post office.
- Generally sympathetic aluminum two-over-two double-hung windows elsewhere.
- Characteristic curved entry to post office area.
- Characteristic concrete canopy at rear loading dock.

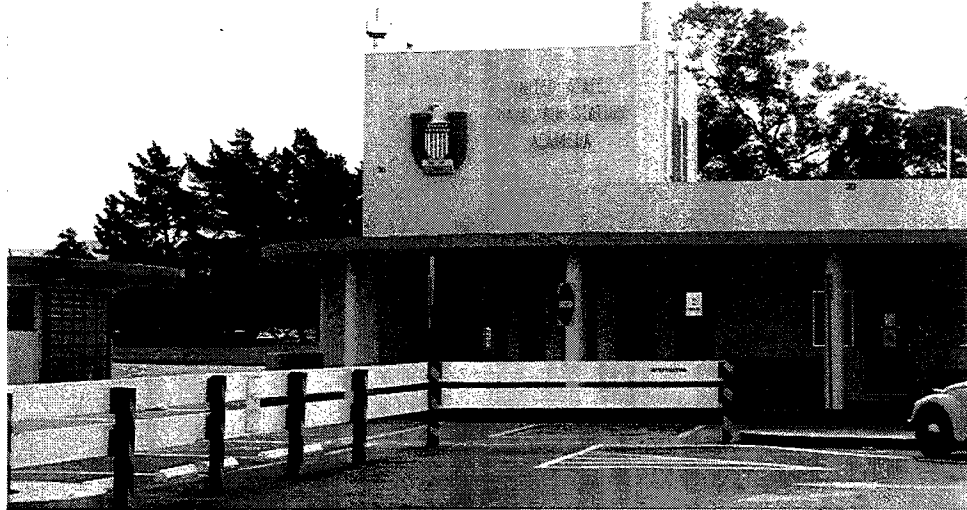
**Photograph 33.** Gate House, Building 30.

Buildings 30 and 31 were literally “gateway” buildings for the NAS Alameda and, for this reason, were given a degree of attention not commonly found in utilitarian buildings of this sort. The two buildings, along with the original gate posts to the east, were clearly designed as a group and are consistent with the design theme for the historic district. Building 30 is shown in **Photograph 33**. Among the character-defining elements are:

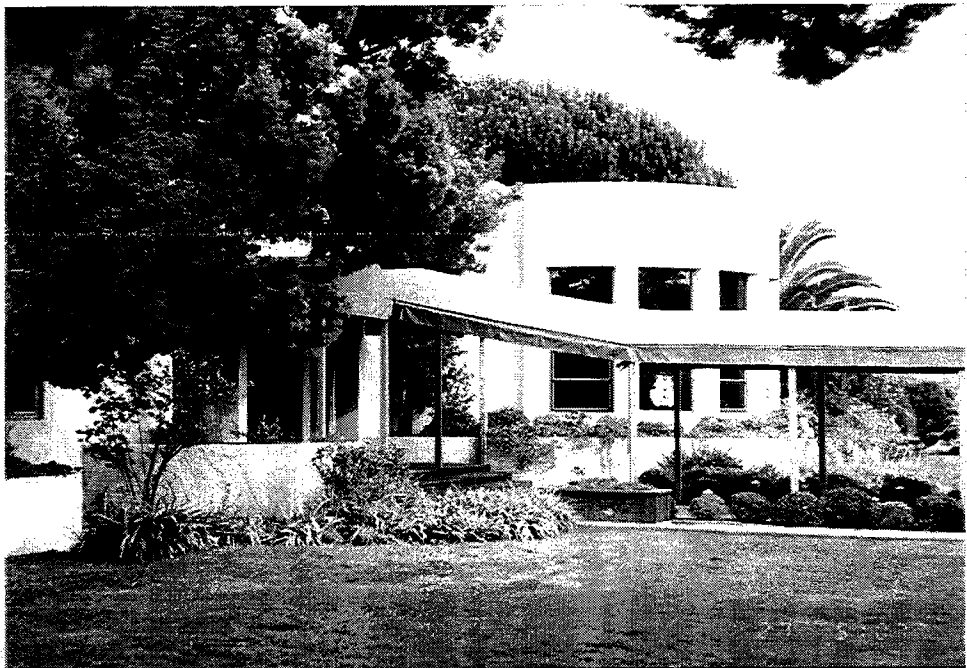
**Photograph 34.** Rounded concrete room, Building 60.

- Rounded main room at the facade, shown in **Photograph 34**.
- A few remnant original windows, including stacked windows in the rear patio area and to one side of the facade.

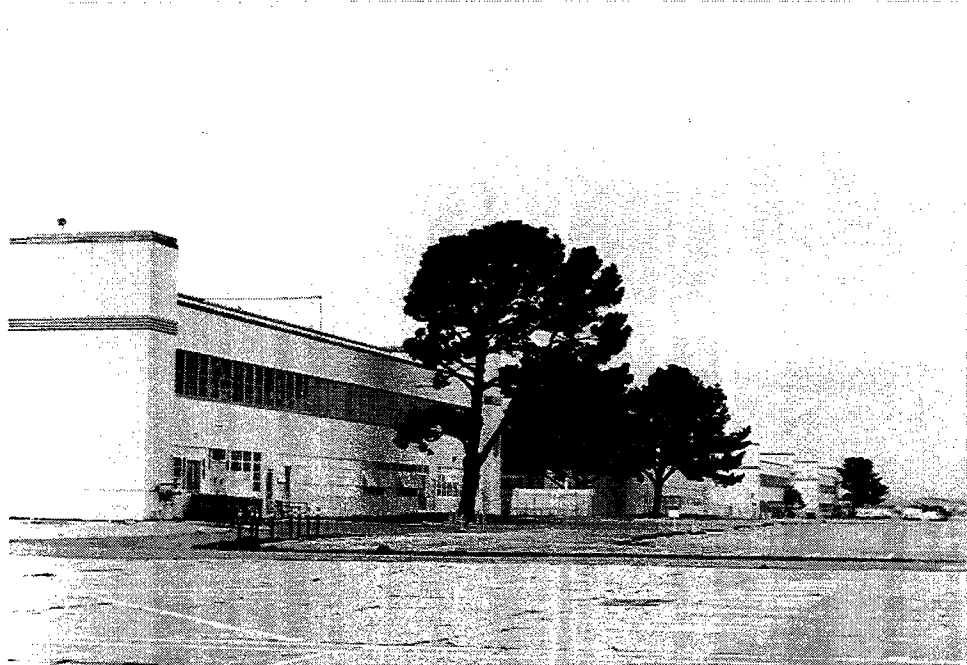
**Photograph 37.** Side office wings of Buildings 21-23.

The seven hangars are large, steel framed buildings, surfaced in thick stucco with tall concrete foundations, or bulkheads. At the two ends of each building, the “walls” are taken up almost entirely by the hangar doors, along with the pockets for those doors at either side. These large pockets are like pylons in their sculptural form. On the side elevations, the door pocket pylons flank a two-story band of office and shop space. The hangar buildings include shed-roofed light monitors on the rooftop. The basic shape of the end wall is shown in Photograph 34; the shape of the side office wing is shown in **Photograph 37**.

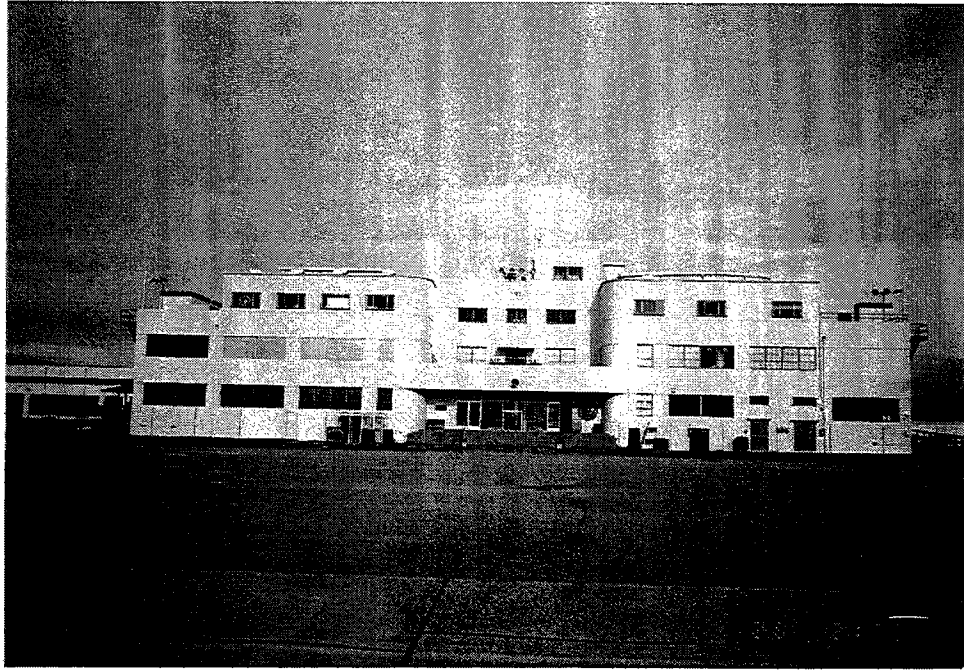
**Photograph 38.** Runway (south) elevation of Building 77.

Building 77 is in the Hangars Area but is a much different building type. Because it was a gateway building -- a building frequented by the visiting public -- Building 77 was treated architecturally as if it were part of the Administrative Core. The front of the building -- the elevation meant for public enjoyment -- faces the taxiway. At this elevation, Building 77 is a very Moderne structure, with curved surfaces leading to the central entry, as shown in **Photograph 38**. The entry includes a wide concrete stairway. The rear (north elevation) of the building faces the Shops Area and is much more utilitarian in design. The rear and side elevations are shown in **Photograph 39**.

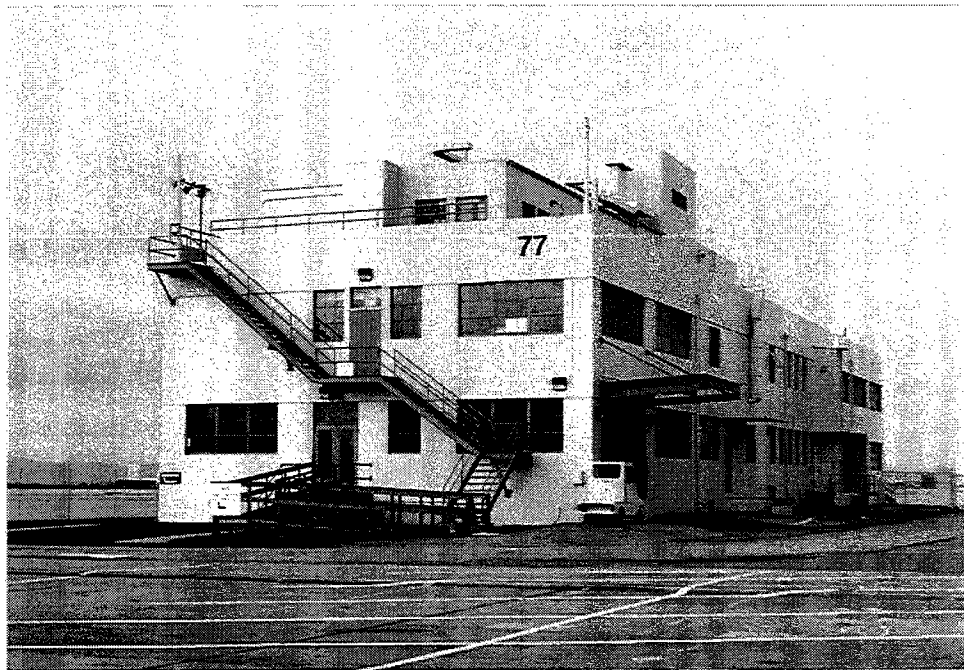
**Photograph 39.** Rear and side elevations of Building 77.

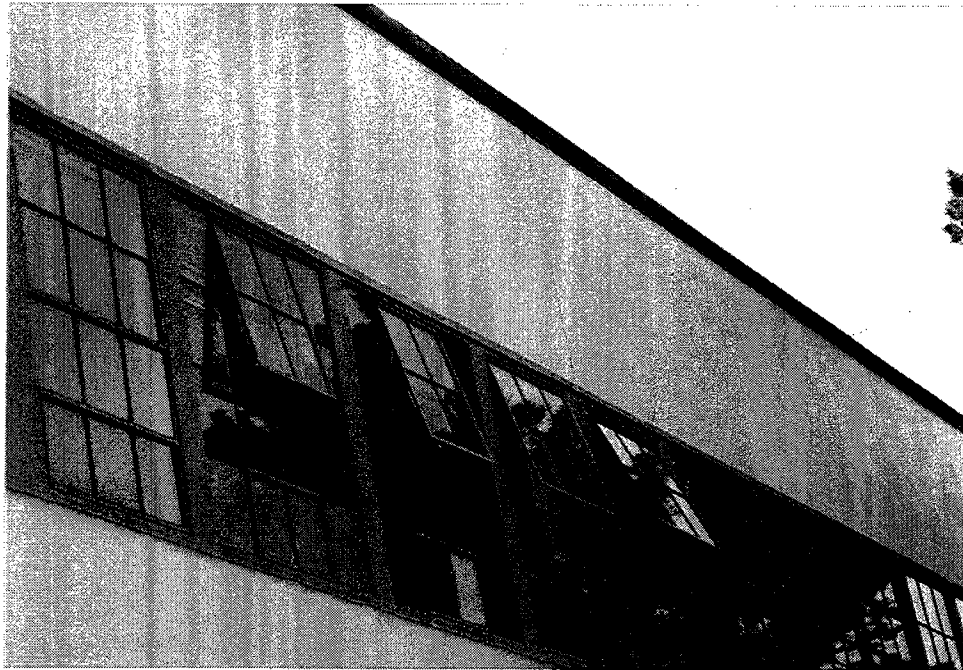
**Photograph 40.** Building 20, showing steel industrial sash with awning openings, typical of hangars.

Smaller windows and doors are found on the side office wings, behind the hangar door pockets. The two-story office wings include two wide bands of steel industrial sash. The steel industrial sash generally includes 16 panes in each panel, four of which open in an awning manner. In nearly all cases, the original steel industrial sash appear to be in place and operational. **Photograph 40** shows the steel industrial sash on the second story of the east side of Building 20. Building 20 is currently in use. It will be observed that many of the windows shown in that photograph have been opened, indicating the windows are operable. Retaining operational windows is a key consideration in maintaining historic buildings in an area with the climate of Alameda Island, in which windows may be opened virtually year around.

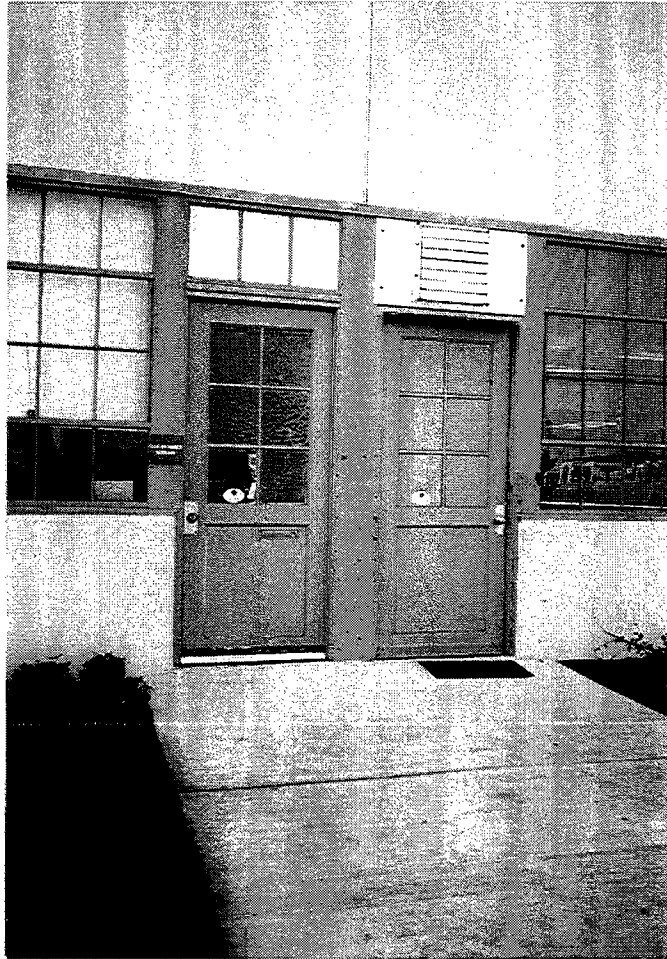
**Photograph 41.** Typical steel personnel door, hangars.

many instances, these transoms have been blocked off or otherwise modified, as shown in this photograph. While minor in relation to the scale of the building, this type of modification should be discouraged during the design review process.

The side office wings of the hangars also include many original steel personnel doors, two of which are illustrated in **Photograph 41**. The original steel doors included steel transoms. In

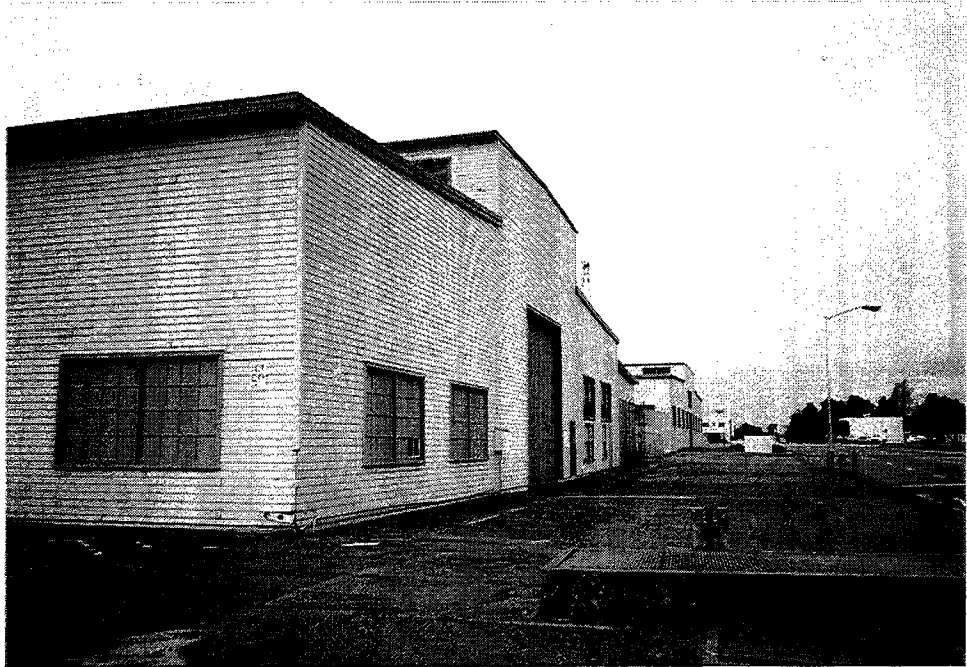
**Photograph 42.** East sides of Buildings 91 and 92, wood frame warehouses.

One group comprises Buildings 91 and 92. These are wood framed shops buildings, of a type built by the Navy at many locations during World War II. The form is defined by two large shed roofed shop wings with a shallow gable-roofed light monitor at the center; this form is shown in **Photograph 42**. The buildings are sided in a horizontal board, called “drop siding”; the manner in which these board are joined is shown in **Photograph 43**. Building 102, a small building near Buildings 42, 43, and 44, is also sided in drop siding.

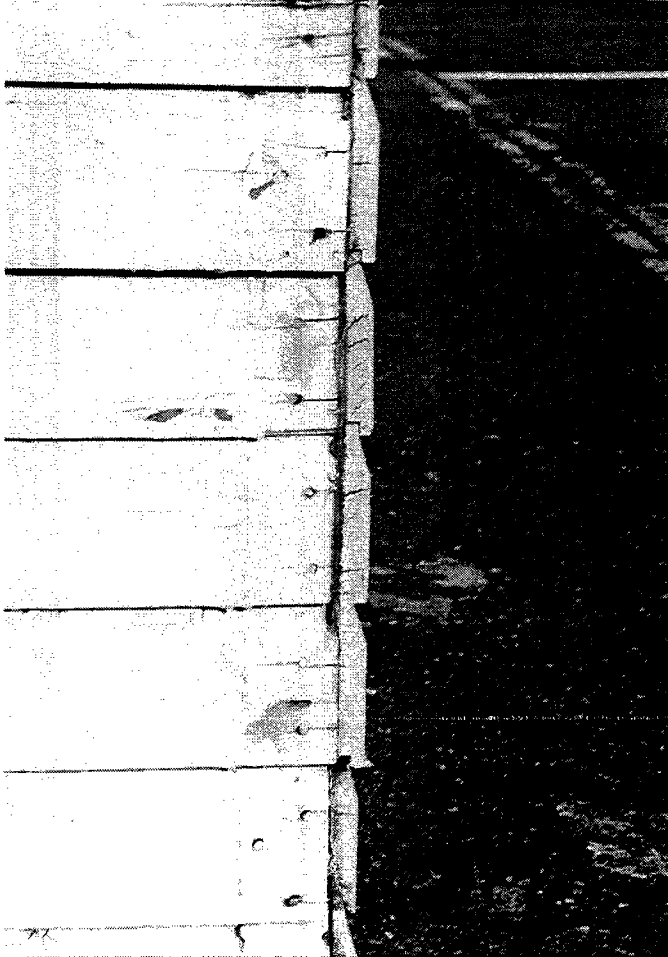
**Photograph 43.** Drop siding on Building 91.

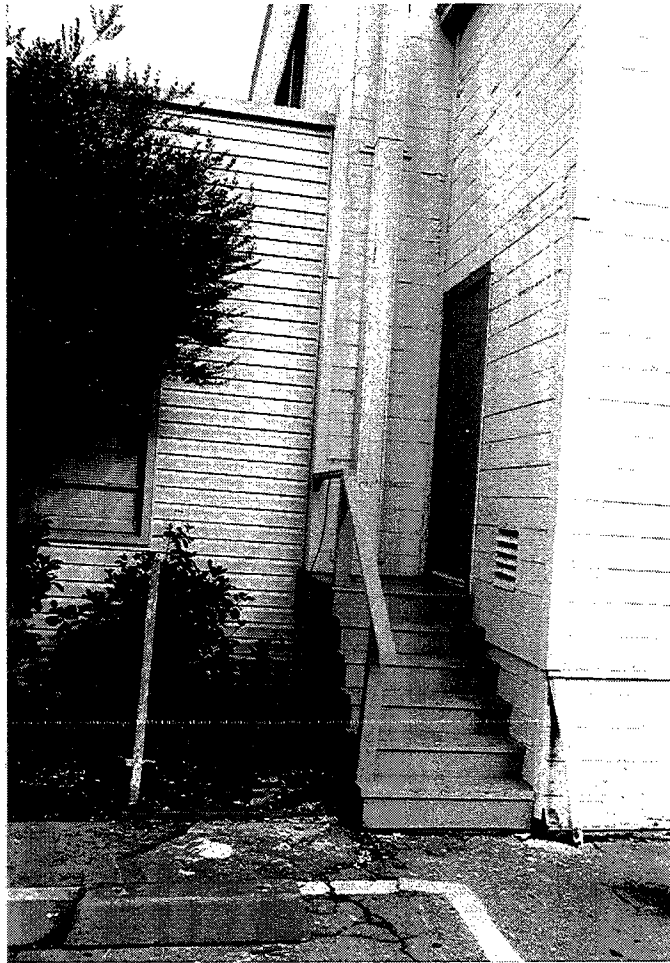
**Photograph 45.** New vinyl siding on office wing of Building 101.

Buildings 101 and 114 are flat-roofed, wood-frame warehouses with office wings, located in the Shops Area near the center of the historic district, south and east of Building 1. At Building 101, the office and warehouse spaces are quite different in appearance. The building is U-shaped, with the office wing at the west enclosure of the U. Both the office and warehouse wings are sided in flush horizontal boards with shiplap joints, similar to the siding used on the Chapel (Building 94). An early addition was built on the north side of the building; it was sided in wooden drop-siding, rather than the flush board used elsewhere. The south side of the office wing was recently re-sided with a vinyl siding, in the shape of drop siding. The building is shown in **Photograph 44**; **Photograph 45** is a detailed view of the vinyl siding on the office wing.

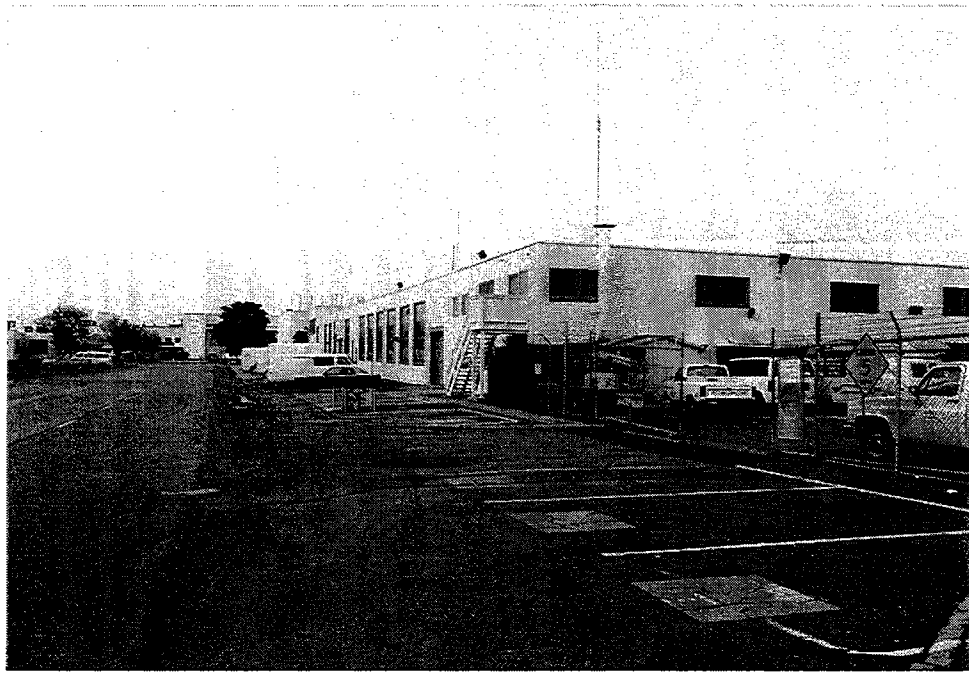
**Photograph 46.** General view of Building 114.

Building 114 is similar to Building 101 in that it is a flat-roofed, wood frame and wooden sided warehouse building with an attached office wing. Building 114, however, is sided in a v-groove wooden board, not found elsewhere within the historic district. There appear to be no major alterations to Building 114; it is shown in **Photograph 46**.

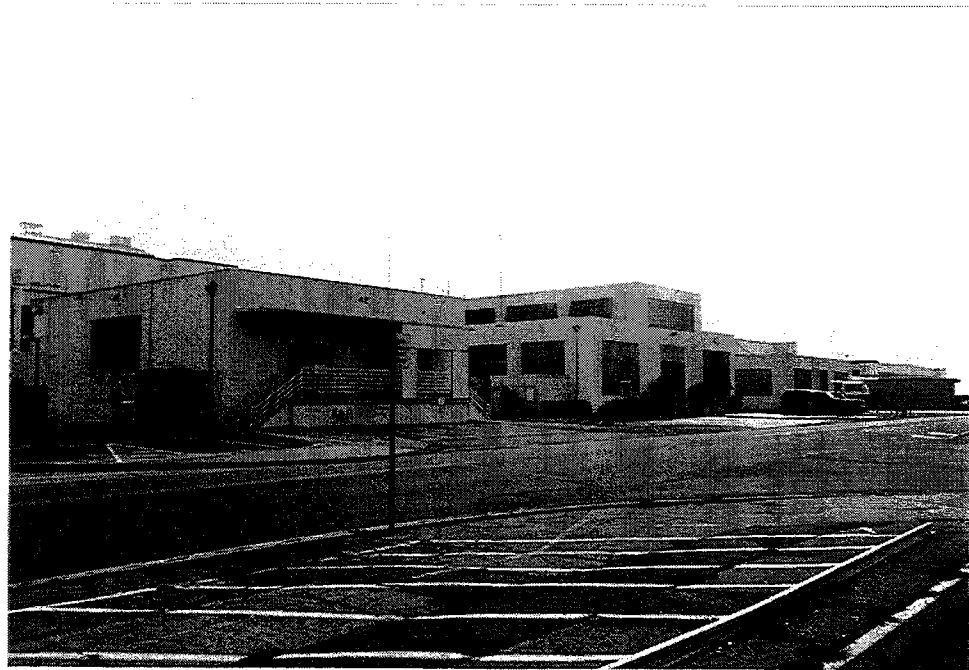
**Photograph 47.** General view of Buildings 42, 43, and 44.

A discrete group of buildings in the Shops Area are three concrete shops at the western edge of the area; these are Buildings 42, 43, 44. These small buildings are shown in **Photograph 47**. These are flat-roofed, reinforced concrete buildings. These buildings include relatively few windows and doors. Although similar, the buildings are not identical. Building 43 includes a flat-roofed light monitor.

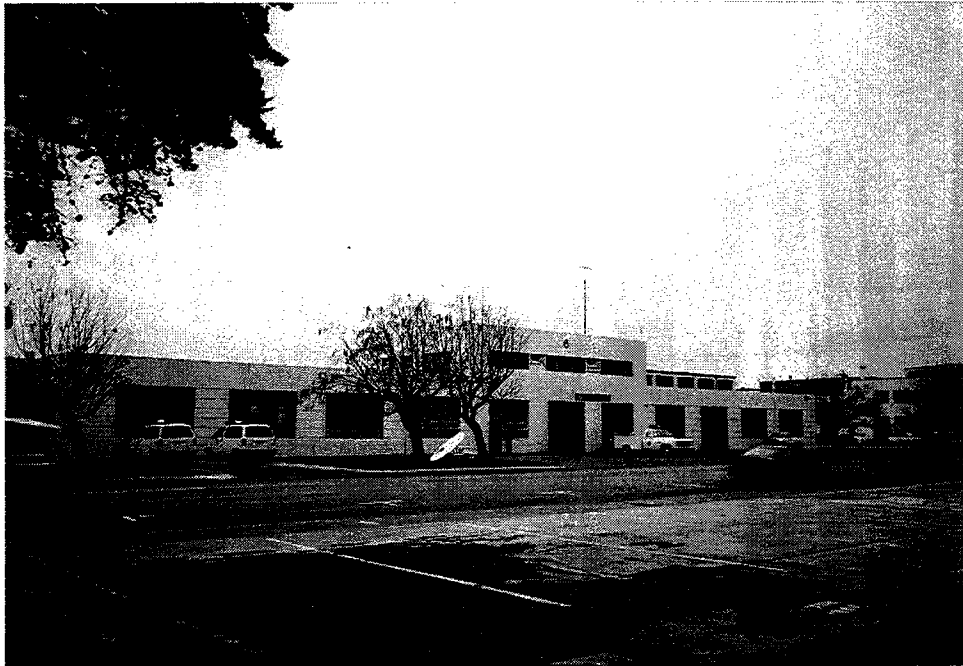
**Photograph 48.** Facade of Building 6.

Buildings 6, 8, and 9 are unique among the Shops Area buildings. Building 6 is a concrete fire station building, located within the Shops Area. It was not a shop functionally and was designed in a manner more consistent with the Administrative Core than with the remainder of the Shops Area. It is finished in smooth concrete. It is a C-shaped building with a two-story facade and two wings of vehicle bays. The basic form of the building is shown in **Photograph 48**.

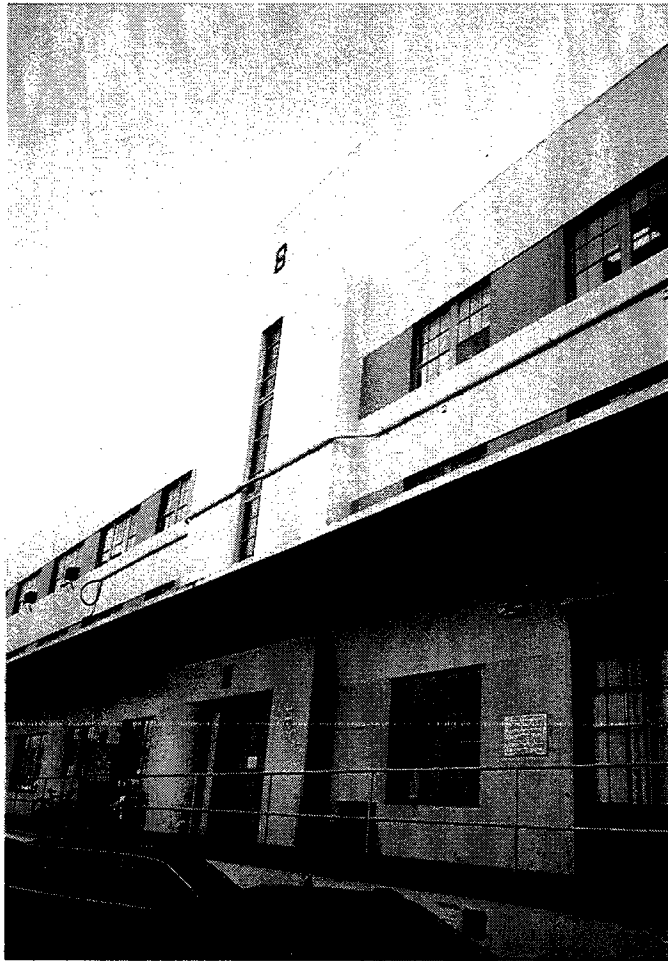
**Photograph 49.** General view of Building 8.

Building 8 is a huge two-story reinforced concrete warehouse, built during the pre-war period of construction at the station, when high-quality, permanent construction was still being emphasized. Like the fire station, Building 8 shares many structural elements with buildings in the Administrative Core, including its flat roof, smooth concrete finish, and horizontal emphasis. **Photograph 49** shows one side of this massive building.

Building 8 is even more integrated with the design of the Administrative Core. It features a strong vertical element at the entry, similar to the entry pavilion of Building 1; this may be seen in **Photograph 49**. It also includes a curved doorway surround, similar to the main entry to Building 18; it is also shown in **Photograph 49**. Building 8 includes a very handsome curving concrete canopy at the loading docks area; this may be seen in **Photograph 57**.

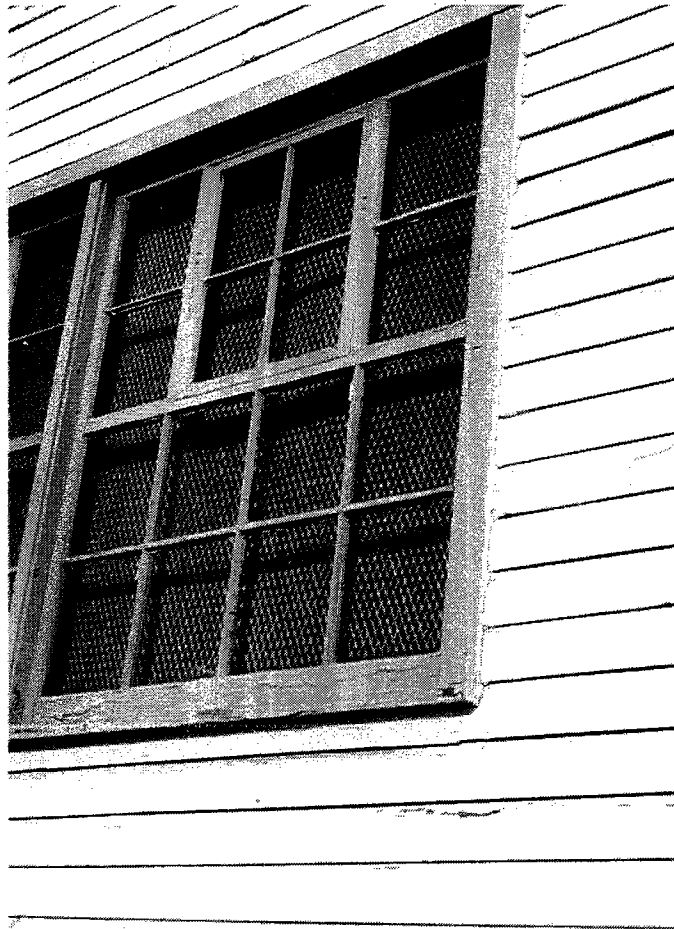
**Photograph 51.** Wooden industrial sash in Building 92.

The wood frame buildings -- 91, 92, 101, 102, and 114 -- include wooden windows, of a variety of patterns. Building 91 and 92 generally include large wooden industrial sash with a center pivot operational window; this window type is illustrated in **Photograph 51**. A similar type of wooden industrial sash was used on the warehouse wings of Building 101. The office wing of Building 101 included an unusual three-over-three double-hung wooden window. On the south side of the office wing of Building 101 (where the vinyl siding was installed), the windows were replaced with one-over-one aluminum double-hung windows. Building 114, while otherwise similar to Building 101, was fitted with steel industrial sash, except in the office wing, which includes two-over-two double-hung wooden sash. The wood frame shops also include several types of sliding wooden industrial doors.

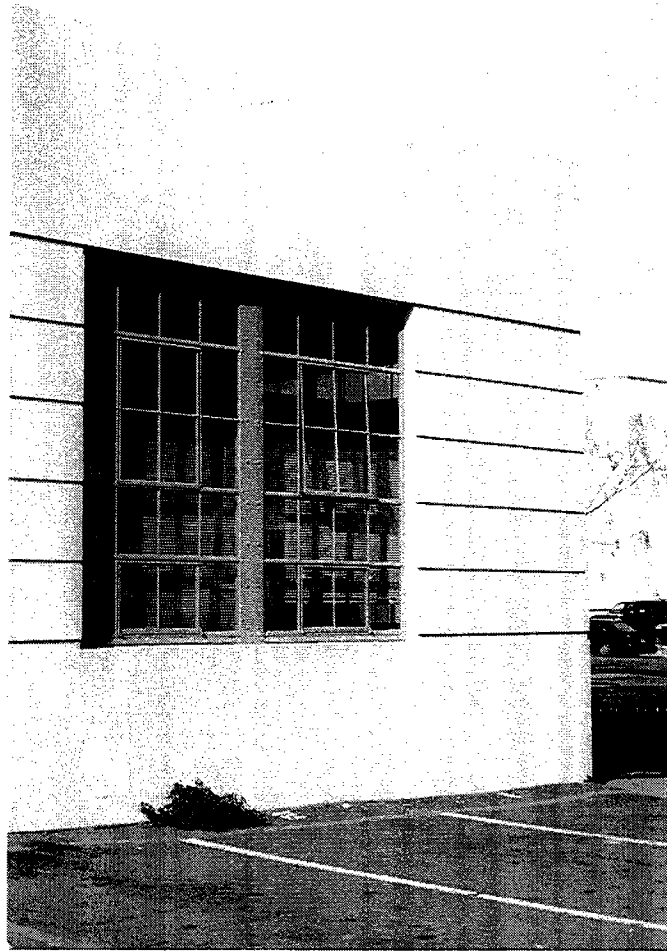
**Photograph 52.** Steel sash in Building 6.

Building 6, the fire station, also includes steel industrial sash. These windows include both awning and hopper type operations sash, i.e. windows hinged at either the top or bottom. An example is shown in **Photograph 52**. The building includes numerous vehicular doors, most of which have been replaced through the years with metal roll-up doors. A few original doors, however, are still in place; an example is shown in **Photograph 53**.

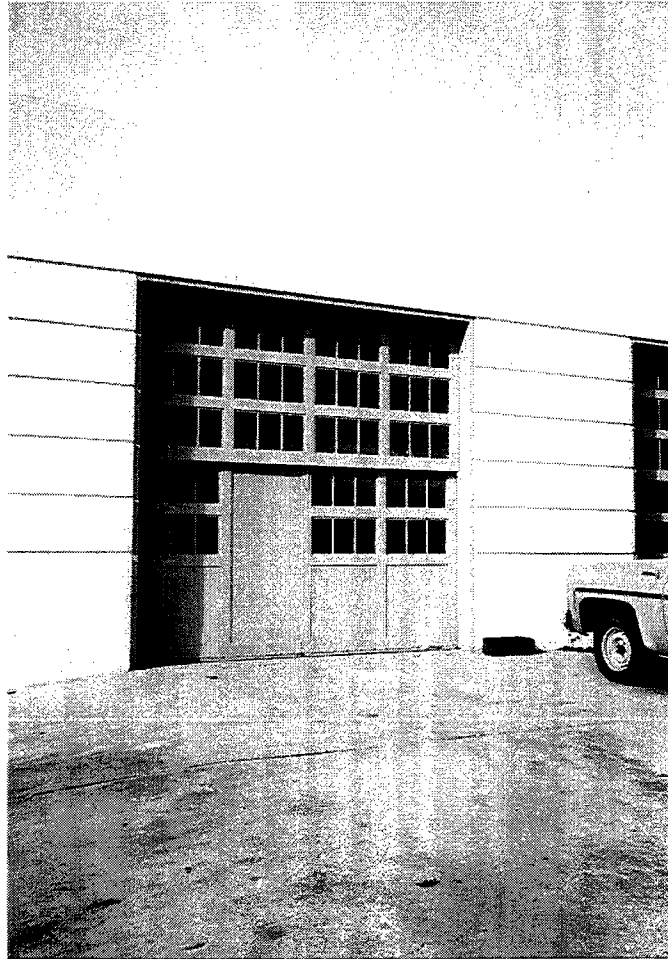
**Photograph 53.** Original vehicular door, Building 6.

Buildings 6 and 8 are notable, however, for the degree to which these utilitarian buildings were integrated into the overall design theme of the base, as exemplified by buildings in the Administrative Core. Building 6 includes the quoin-like incised concrete features, found throughout the Administrative Core; this may be seen in **Photograph 53**.

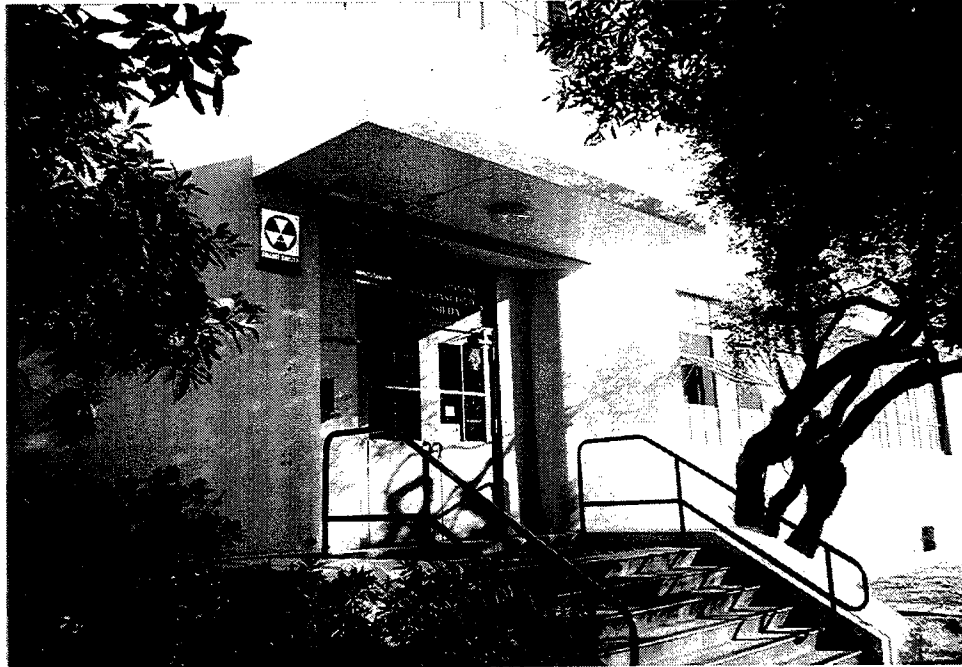
**Photograph 54.** Original steel personnel door, Building 8.

Building 8 includes steel industrial sash throughout. It also includes numerous original steel personnel doors, one of which is shown in **Photograph 54**. As a warehouse, the bulk of the doors in this building are wide industrial openings. Most of the industrial doors appear to have been replaced.

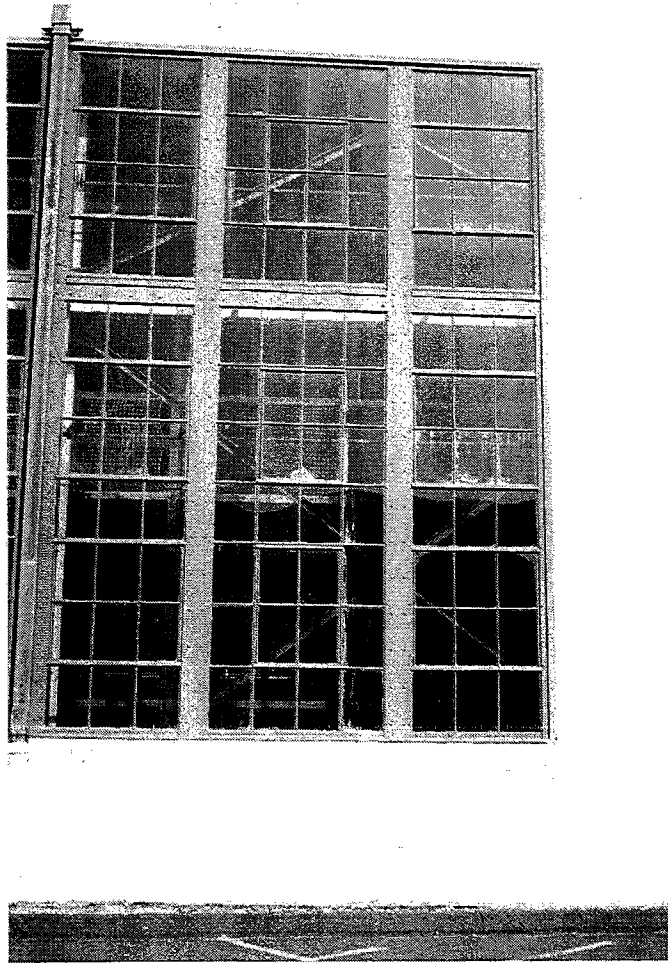
**Photograph 55.** Industrial sash, Building 9.

industrial sash, as shown in **Photograph 55**. It also includes tall doors that resemble hangar doors, as shown in **Photograph 56**.

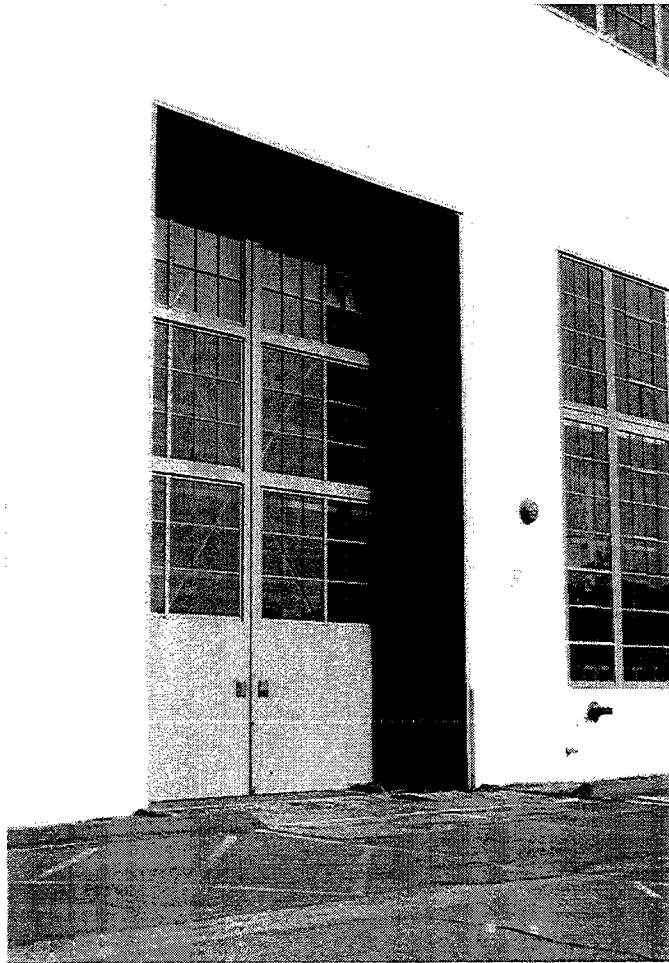
**Photograph 56.** Industrial doors, Building 9.

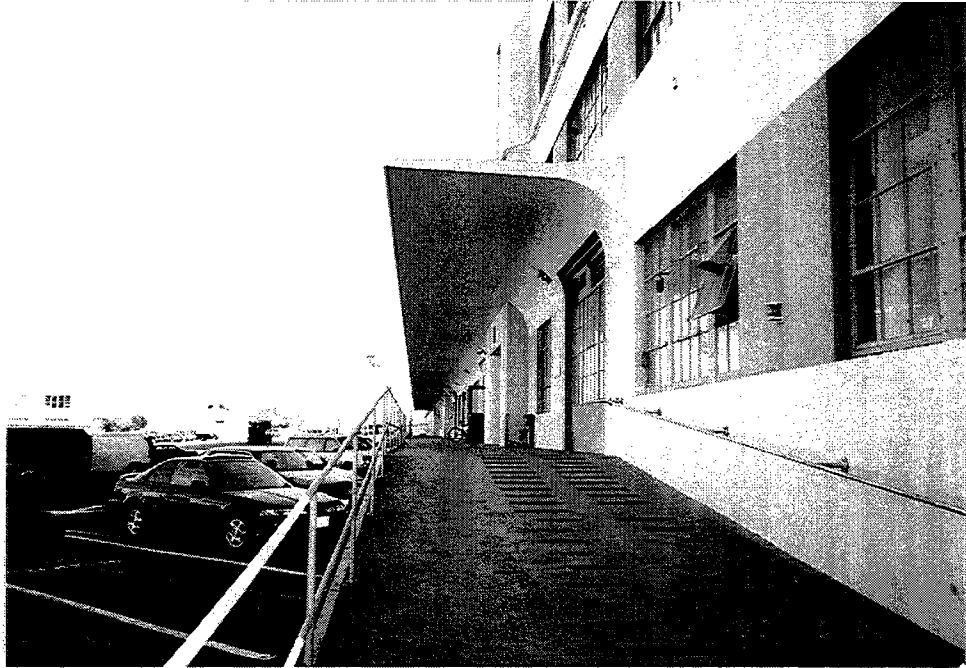
**Photograph 57.** Curved concrete canopy, Building 8.

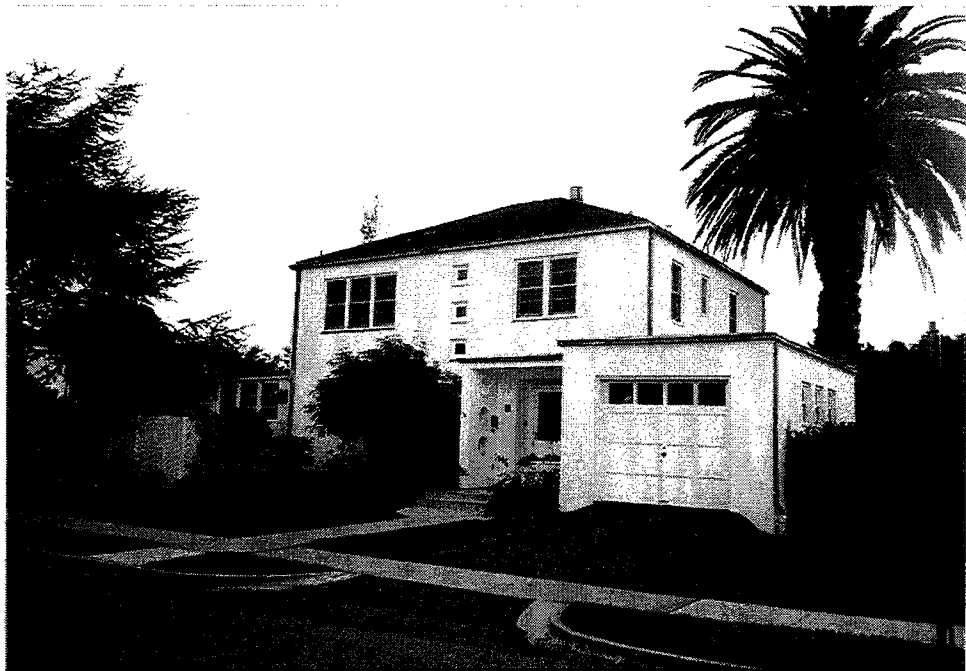
**Photograph 58.** Typical Officers' Quarters building.

Both the two-story officers' quarters and one-story NCO quarters are wood-frame buildings, sided in thick stucco on concrete foundations. The basic form of the officers' quarter building is shown in **Photograph 58**; the NCO quarters building is shown in **Photograph 59**.

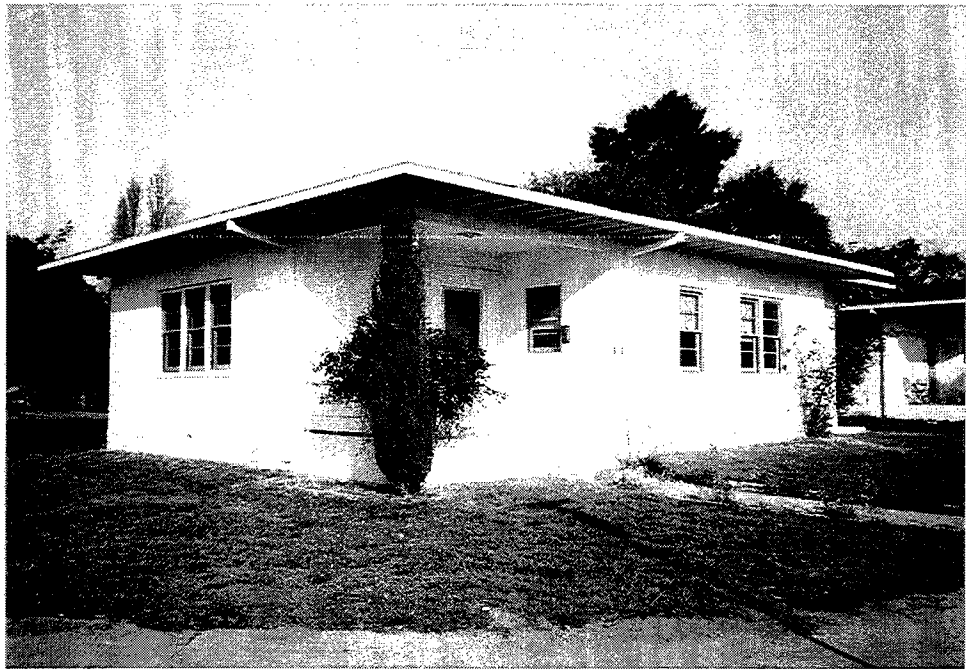
**Photograph 59.** Typical NCO quarters building.

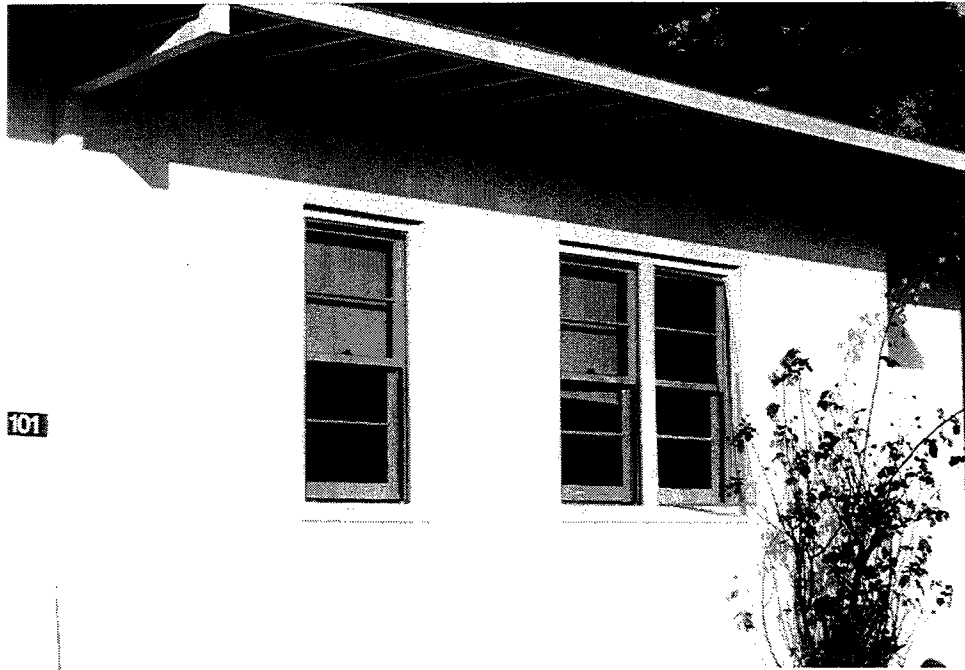
**Photograph 61.** Window detail, NCO Quarters.

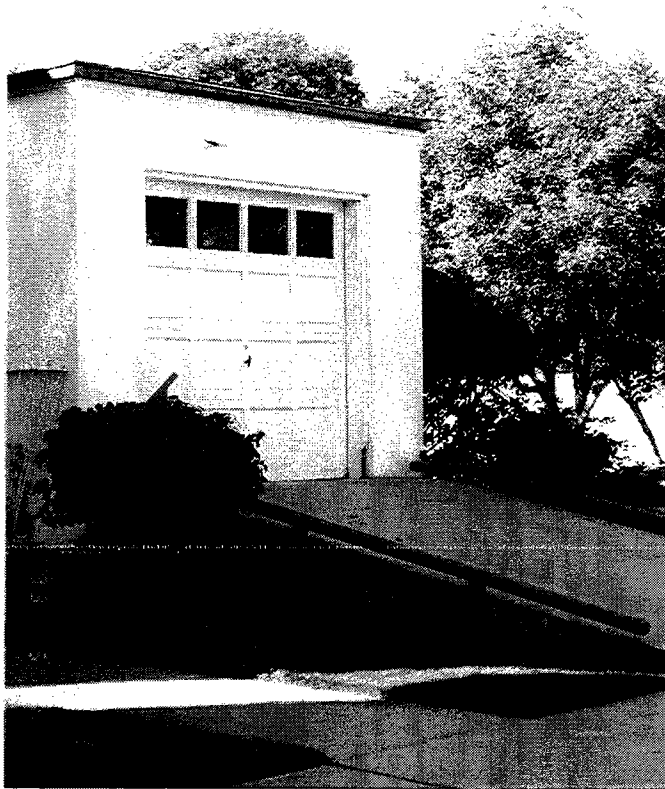
**Photograph 62.** Garage door, Officers' Quarters.

The residential units within the NAS Alameda Historic District are remarkably unaltered. It appears that all, or nearly all, of the original windows and doors are still in place. The windows in both housing types are two-over-two double-hung wooden sash, consistent with the original window pattern throughout the Administrative Core. The windows in the officers’ quarters are detailed in **Photograph 60**. A typical window in the NCO quarters is shown in **Photograph 61**. Virtually all of the front doors are also original, on both types of housing. In the officers’ quarters, the front door is wooden with four wooden panels and four lights. In the NCO quarters, the front door is a five-panel wooden door with sidelights. In addition to the entry doors, the officers’ quarters retain original, or at least very early, garage doors. A typical garage door is shown in **Photograph 62**.
