# CHAPTER FOUR CONDITION ASSESSMENT

## Chapter 4 Condition Assessment

City of Alameda  
Sewer Master Plan

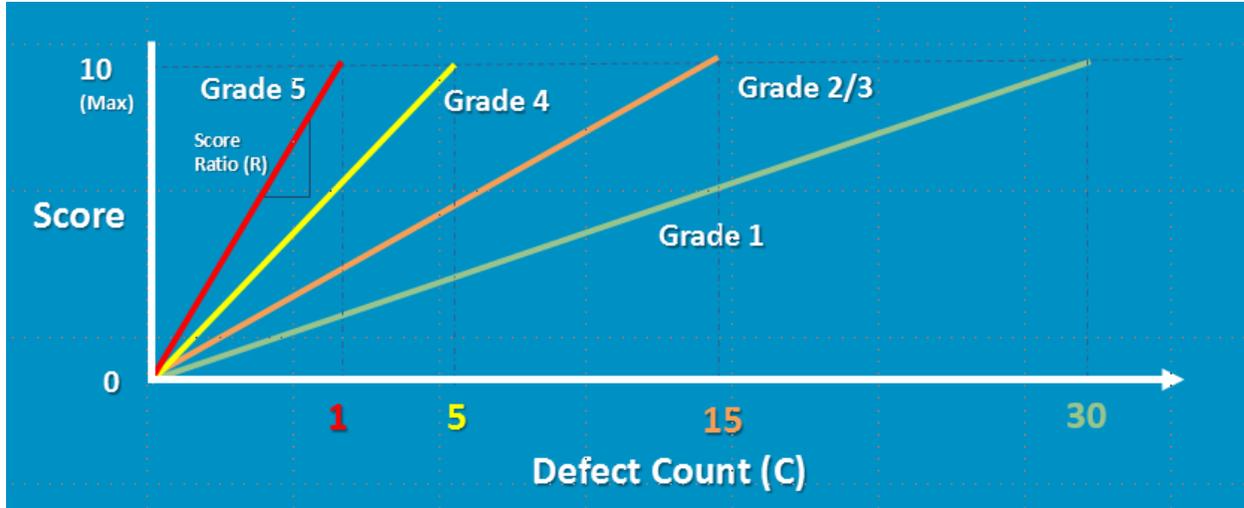
**Figure 4-1: Computation of Structural Grade Scores**

- Grade score = Score Ratio (R) x Defect Count (C)
- Total Structural Grade Score = (R<sub>5</sub> x C<sub>5</sub>) + (R<sub>4</sub> x C<sub>4</sub>) + (R<sub>2/3</sub> x C<sub>2/3</sub>) + (R<sub>1</sub> x C<sub>1</sub>)
- Maximum score = 10

For the purposes of evaluating the Likelihood of Failure (LOF) resulting from structural defects, a scoring system that consolidates the PACP grades was developed for this study. The scoring system provides a single 'structural grade score' based on the CCTV data which ranges from 0 to 10 and accounts for multiple defect ratings and the number of defects. Although a high maximum structural grade is a good indicator of the need for a near-term pipe rehabilitation or repair, the number and severity of other defects in the pipe should also be considered. Therefore, the calculation of the structural grade score gives higher score values for more severe defects but still considers the number of less severe structural defects. Using this approach, all pipes with at least one Grade 5 structural defect are given the maximum structural grade score of 10, but lesser grade defects can also contribute to the structural grade score depending on the number and grade of these defects. **Figure 4-1** illustrates the computation of structural grade scores. The Structural Condition
