TREE REMOVAL NOTICE

Arborist Report
Harbor Bay Parkway- Tree #29

Subject: Harbor Bay Parkway Tree,

Location: South side of HBP, between Abbot fountain and South Loop

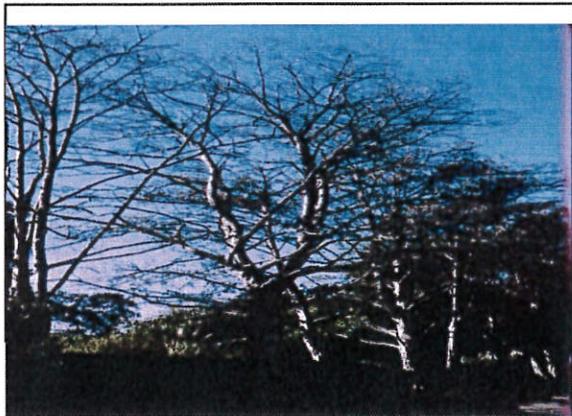
29

This tree is being removed for the following reason Dead due to either phytophthoa or verticillium

The Public Works Department has scheduled the removal of this publicly owned tree after May 27, 2013.

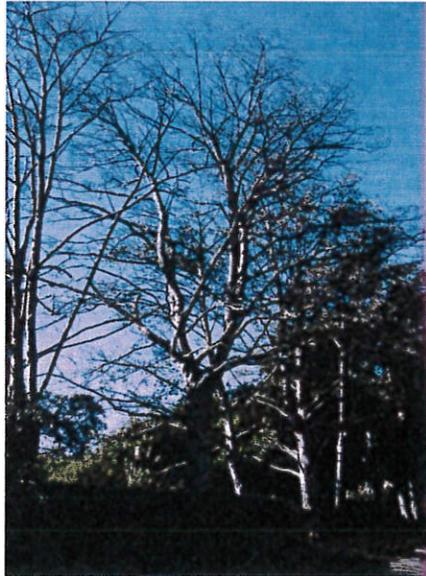
Photo:

Species: Alnus Rhombifolia- White Alder (DBH-22")

Summary: Tree mortality was due to either phytophthora or verticillium, brought on by extreme stress to the root system. The tree is dead and should be removed. There is no urgent safety threat. The tree was inspected on November 5, 2012.

Recommendation: Removal – Dead Tree

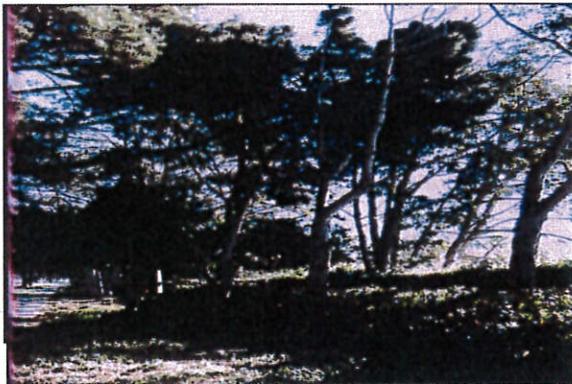
30

This tree is being removed for the following reason Dead due to either phytophthoa or verticillium

The Public Works Department has scheduled the removal of this publicly owned tree after May 27, 2013.

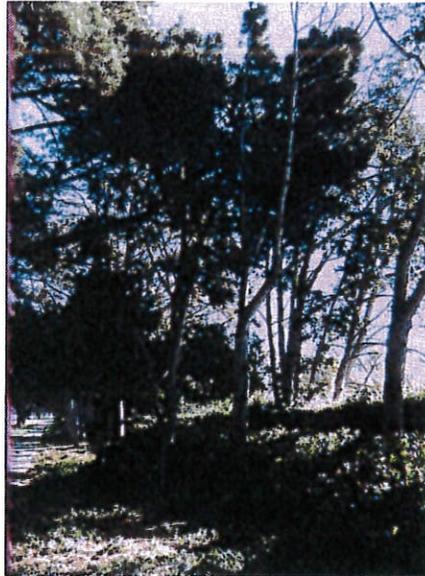
Photo:

Species: Alnus Rhombifolia- White Alder (DBH-12")

Summary: Tree mortality was due to either phytophthora or verticillium, brought on by extreme stress to the root system. The tree is dead and should be removed. There is no urgent safety threat. The tree was inspected on November 5, 2012.

Recommendation: Removal – Dead Tree

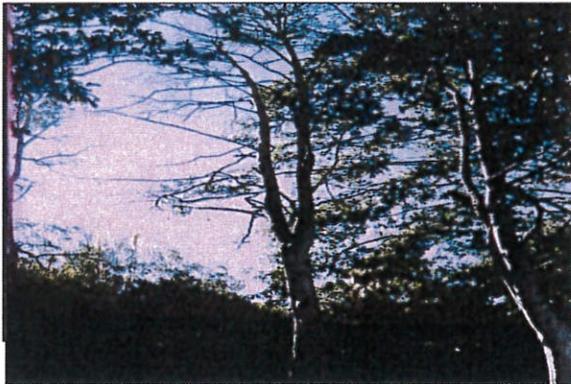
32

This tree is being removed for the following reason Dead due to either phytophthoa or verticillium

The Public Works Department has scheduled the removal of this publicly owned tree after May 27, 2013.

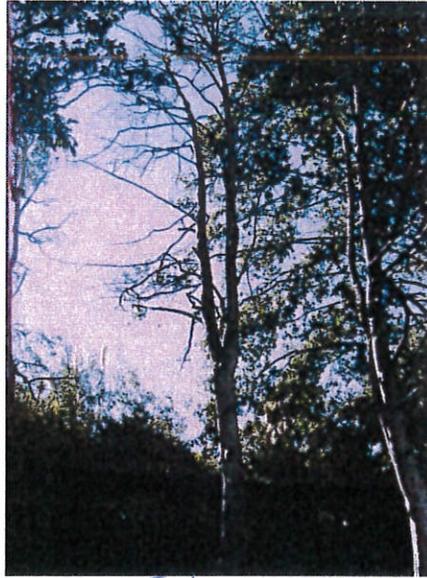
Photo:

Species: Alnus Rhombifolia- White Alder (DBH-15")

Summary: Tree mortality was due to either phytophthora or verticillium, brought on by extreme stress to the root system. The tree is dead and should be removed. There is no urgent safety threat. The tree was inspected on November 5, 2012.

Recommendation: Removal – Dead Tree
