TREE REMOVAL NOTICE

Arborist Report
Harbor Bay Parkway- Tree #33

Arborist Report
Harbor Bay Parkway- Tree #34

Arborist Report
Harbor Bay Parkway- Tree #35

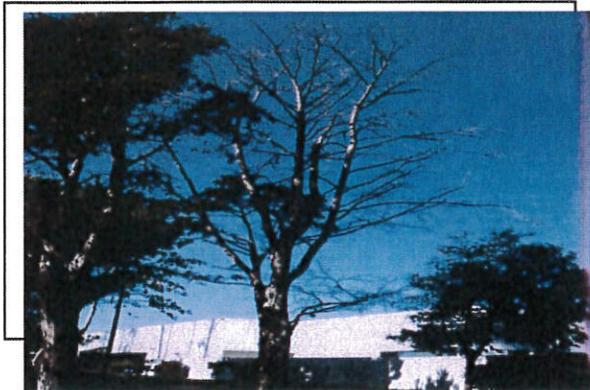
33

This tree is being removed for the following reason Dead due to either phytophthoa or verticillium

The Public Works Department has scheduled the removal of this publicly owned tree after May 27, 2013.

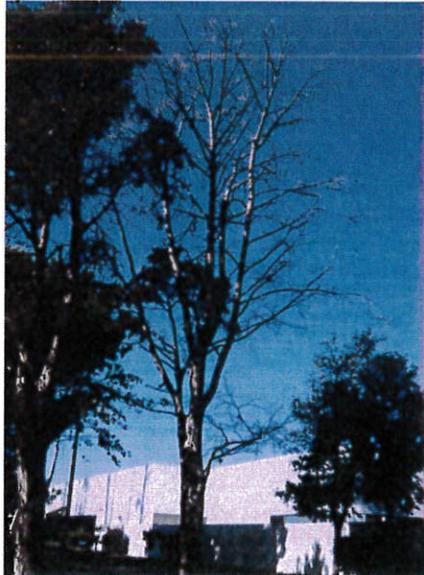
Photo:

Species: Alnus Rhombifolia- White Alder (DBH-18")

Summary: Tree mortality was due to either phytophthora or verticillium, brought on by extreme stress to the root system. The tree is dead and should be removed. There is no urgent safety threat. The tree was inspected on November 5, 2012.

Recommendation: Removal – Dead Tree

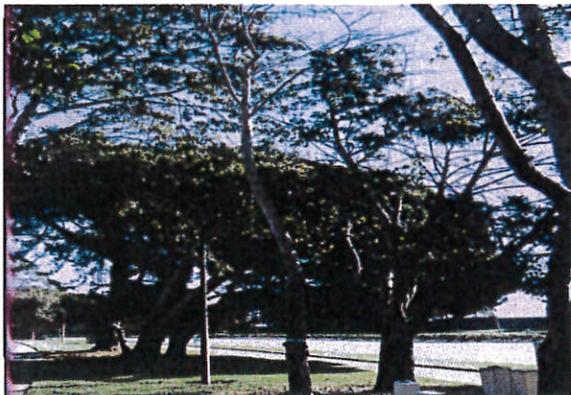
34

This tree is being removed for the following reason Dead due to either phytophthoa or verticillium

The Public Works Department has scheduled the removal of this publicly owned tree after May 27, 2013.

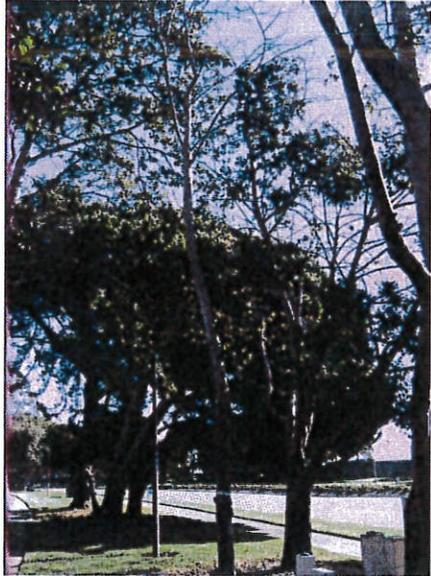
Photo:

Species: Alnus Rhombifolia- White Alder (DBH-11")

Summary: Tree mortality was due to either phytophthora or verticillium, brought on by extreme stress to the root system. The tree is dead and should be removed. There is no urgent safety threat. The tree was inspected on November 5, 2012.

Recommendation: Removal – Dead Tree

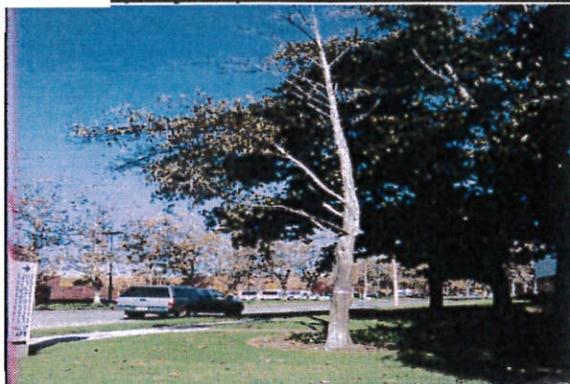
35

This tree is being removed for the following reason Dead due to either phytophthoa or verticillium

The Public Works Department has scheduled the removal of this publicly owned tree after May 27, 2013.

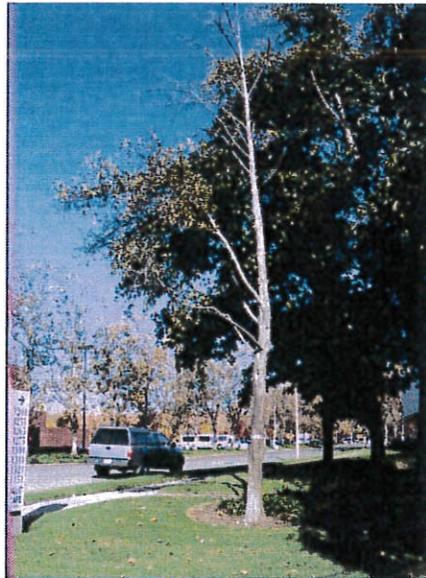
Photo:

Species: Alnus Rhombifolia- White Alder (DBH-9")

Summary: Tree mortality was due to either phytophthora or verticillium, brought on by extreme stress to the root system. The tree is dead and should be removed. There is no urgent safety threat. The tree was inspected on November 5, 2012.

Recommendation: Removal – Dead Tree
